# **BUILDING & PEST INSPECTION**

104 Captain Cook Crescent, Narrabundah ACT 2604

Project Name:  
 NARRABUNDAH RESIDENCE  
 Address:  
 BLOCK 4, SECTION 72, NARRABUNDAH  
 Client:  
 CLASSIC CONSTRUCTION  
 Drawing Title:  
 DEMOLITION PLAN  
 Drawn By: DL Scale: 1:200  
 Project No: 1407 Drawing No.: WDD1

STRUCTURAL DETAILS AND SPECIFICATIONS  
PROPOSED RESIDENCE ON  
BLOCK 4, SECTION 72, NARRABUNDAH A.C.T  
FOR

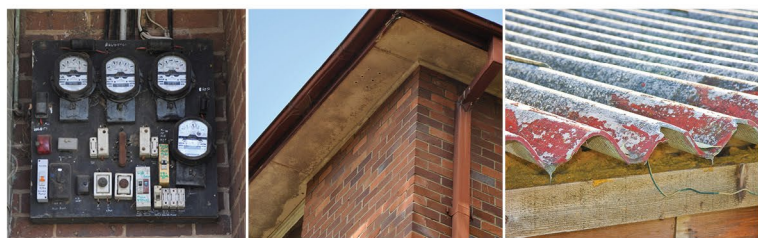
- 1.** Exterior  
roof sheeting, gutters, downpipes,  
ridge capping, eaves, cladding,  
electrical switchboards

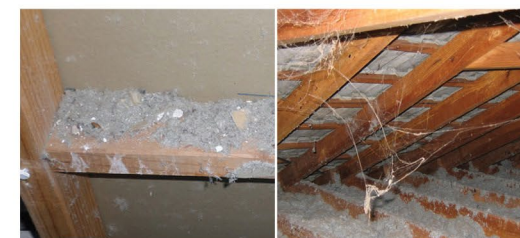
- 5.** Building cavities  
A small number of homes may still contain  
loose fill asbestos insulation in the roof  
cavity, wall cavities or sub-floor space

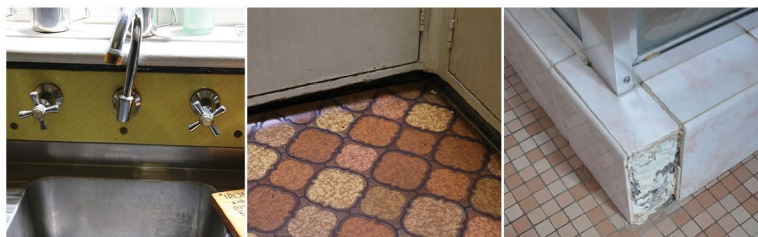
- 2.** Wet areas - bathroom, laundry and kitchen  
wall and ceiling panels, vinyl floor tiles, backing for wall tiles  
and splashbacks, hot water pipe insulation

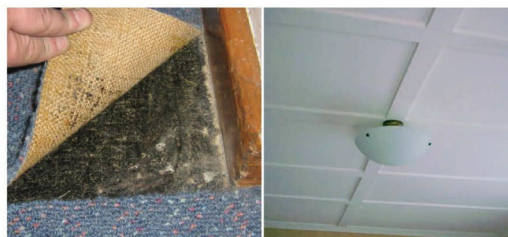
- 3.** Internal areas  
wall and ceiling panels, carpet underlay,  
textured paints, insulation in domestic  
heaters

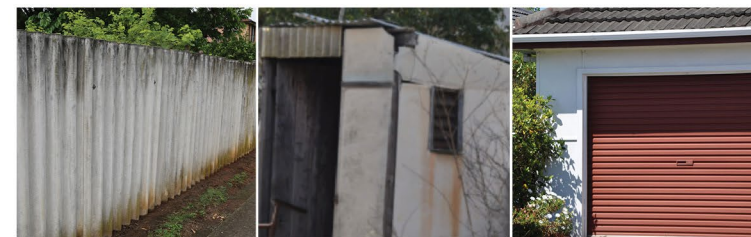
- 4.** Backyard  
fences, sheds, garages, carports, dog kennels, buried or  
dumped waste, letterboxes, swimming pools
