# Report

# Building Report

## COMPLIANCE REPORT

## CONVEYANCING BUILDING FILE INDEX

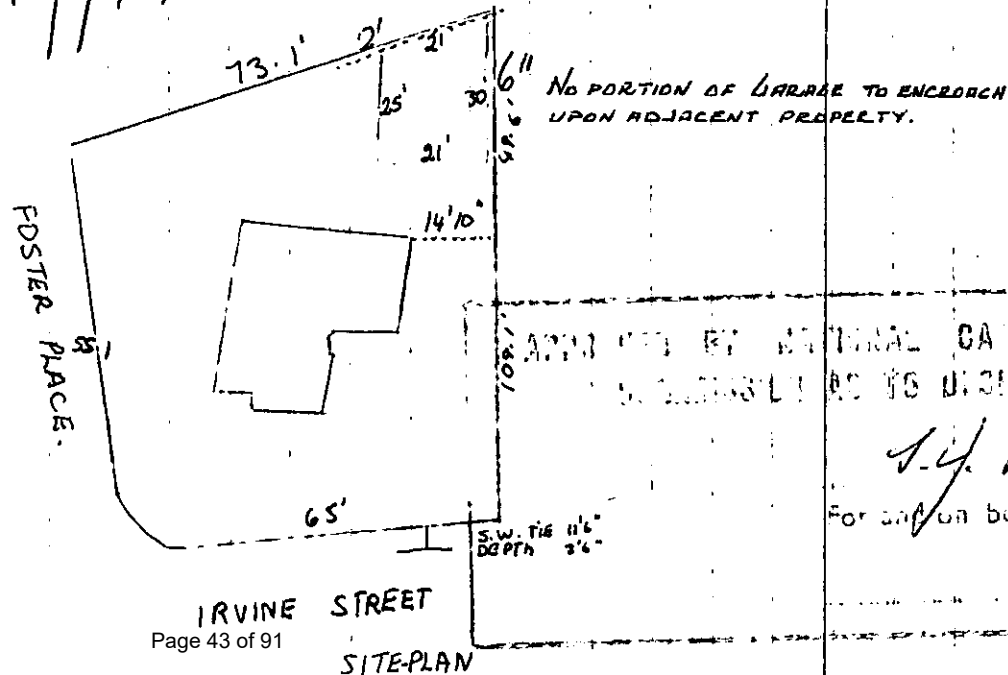
19/47 WATSON

- AGENTS AND SUBMITTERS  
SANDHIA BUILDING REGULATIONS  
PLAN NO. 7034A
- Walls to be of 4 1/2 thick bricks with 9"x9" brick piers.
- Roof: 8"x2" timber beam down centre, 6"x2" beams across galvanised iron (no overhang), gutters + downpipe (connected to stormwater drain).
- Foundations: 3/4 river gravel + sand mixture reinforced
- Floor: 5" slab concrete.
- Doors: 2 tilt-a-door with timber frame.

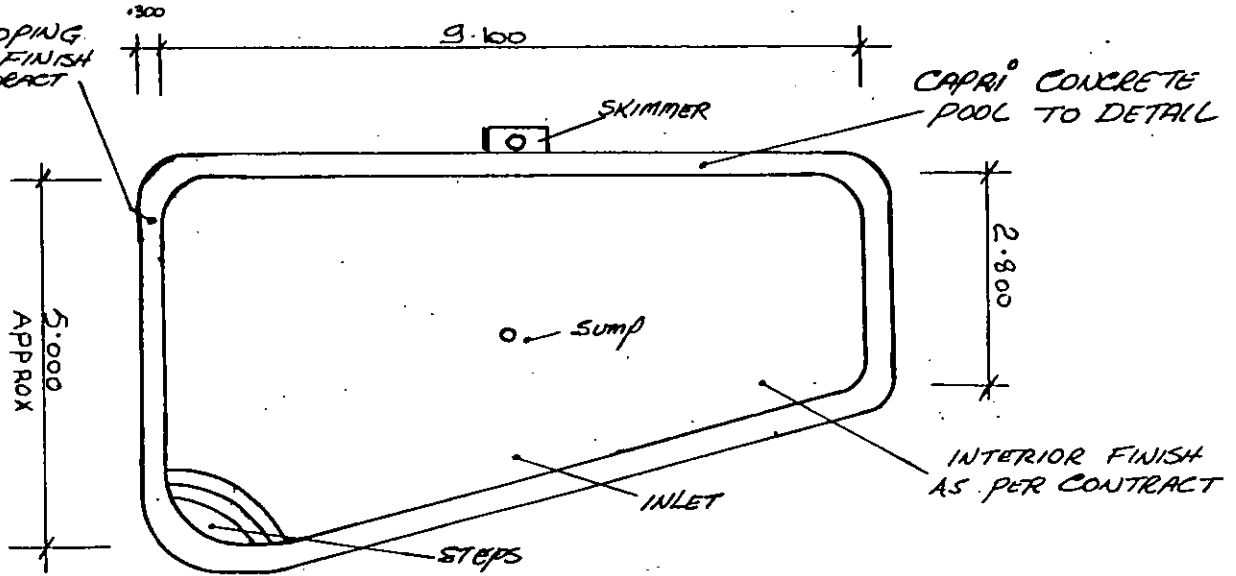
PLAN.

• 300 WIDE COPING  
ALL ROUND FINISH  
AS PER CONTRACT

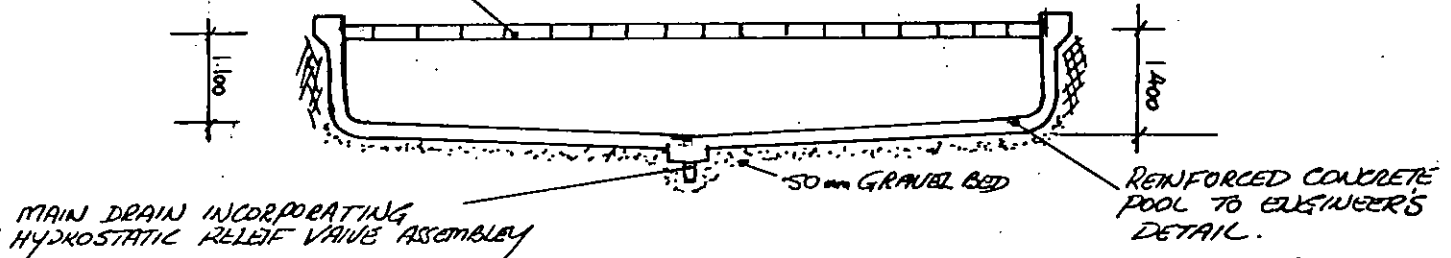
SECTION  
SCALE 1:100

1 ROW CERAMIC TILES TO W.L.

NOTE:  
POSITION OF STEPS, SKIMMER AND  
INLET POSITIONS ARE TYPICAL ONLY  
ACTUAL POSITION DETERMINED ON SITE

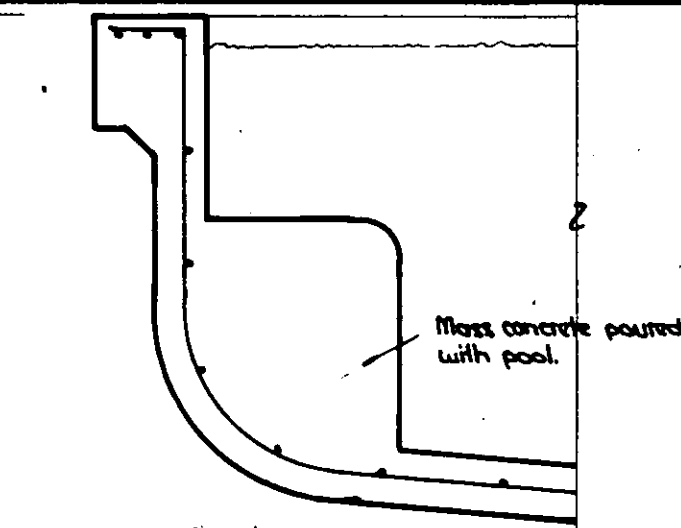
**IF APPLICABLE —**  
**TYPICAL SECTION - SWIM-OUT.**  
 For location see Architectural drawing.

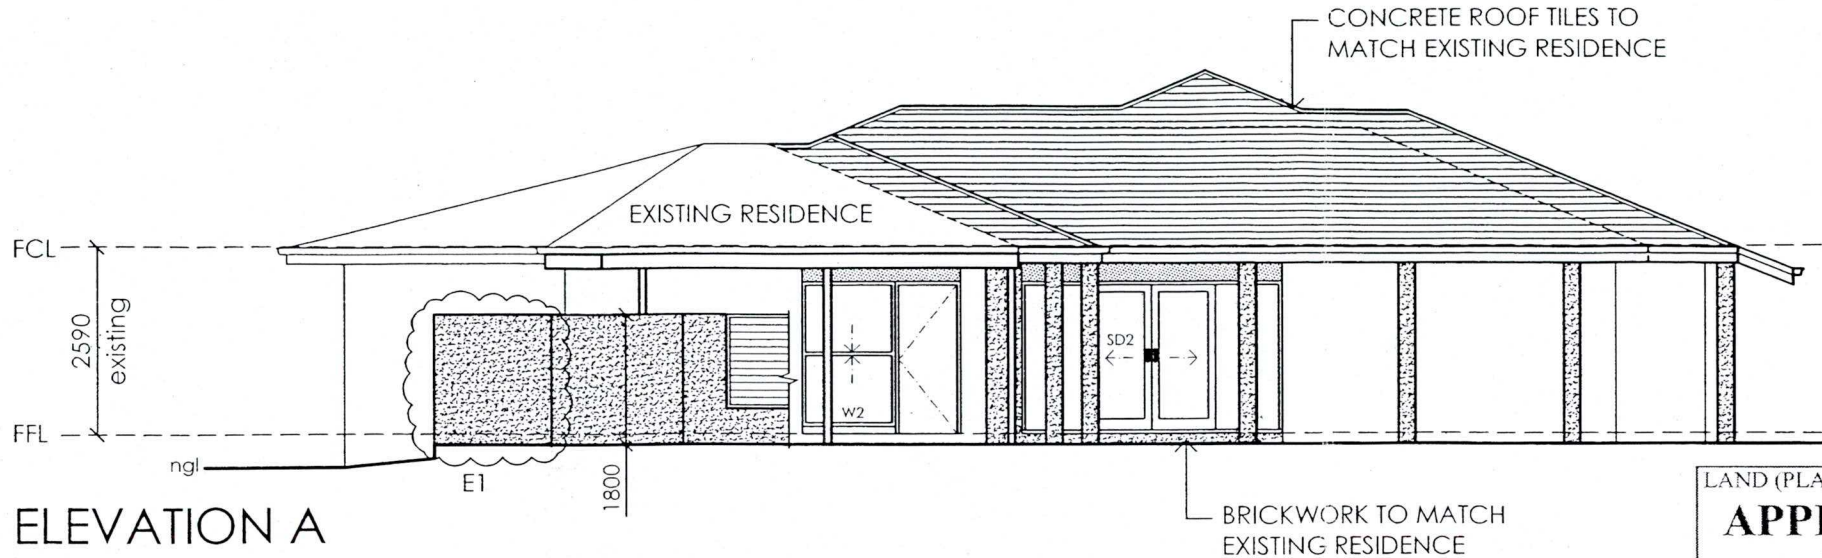
ELEVATION A  
COURTYARD WALL ONLY PARTLY SHOWN FOR CLARITY

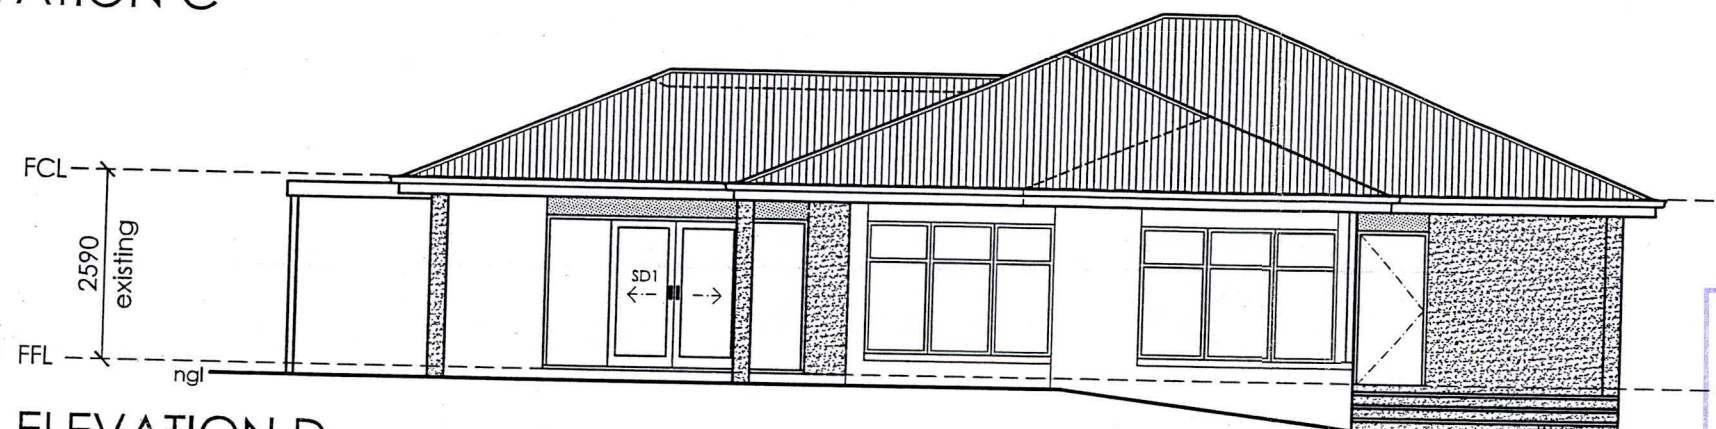
ELEVATION D

COURTYARD WALL NOT SHOWN FOR CLARITY

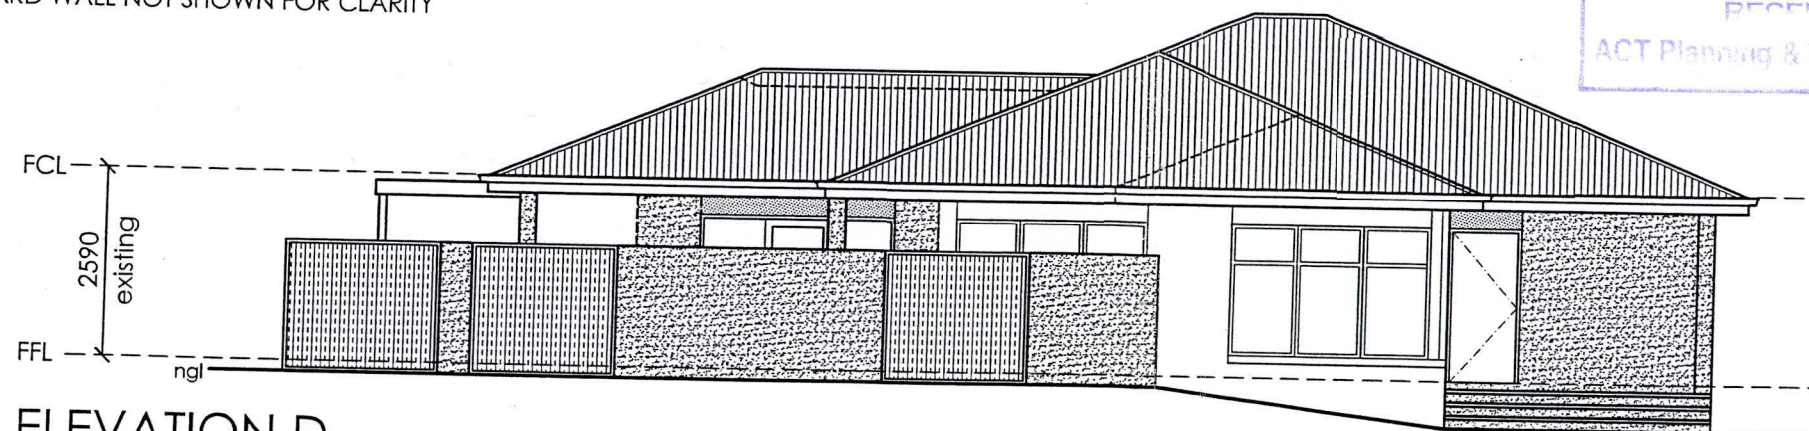
ELEVATION D

SHOWING COURTYARD WALL

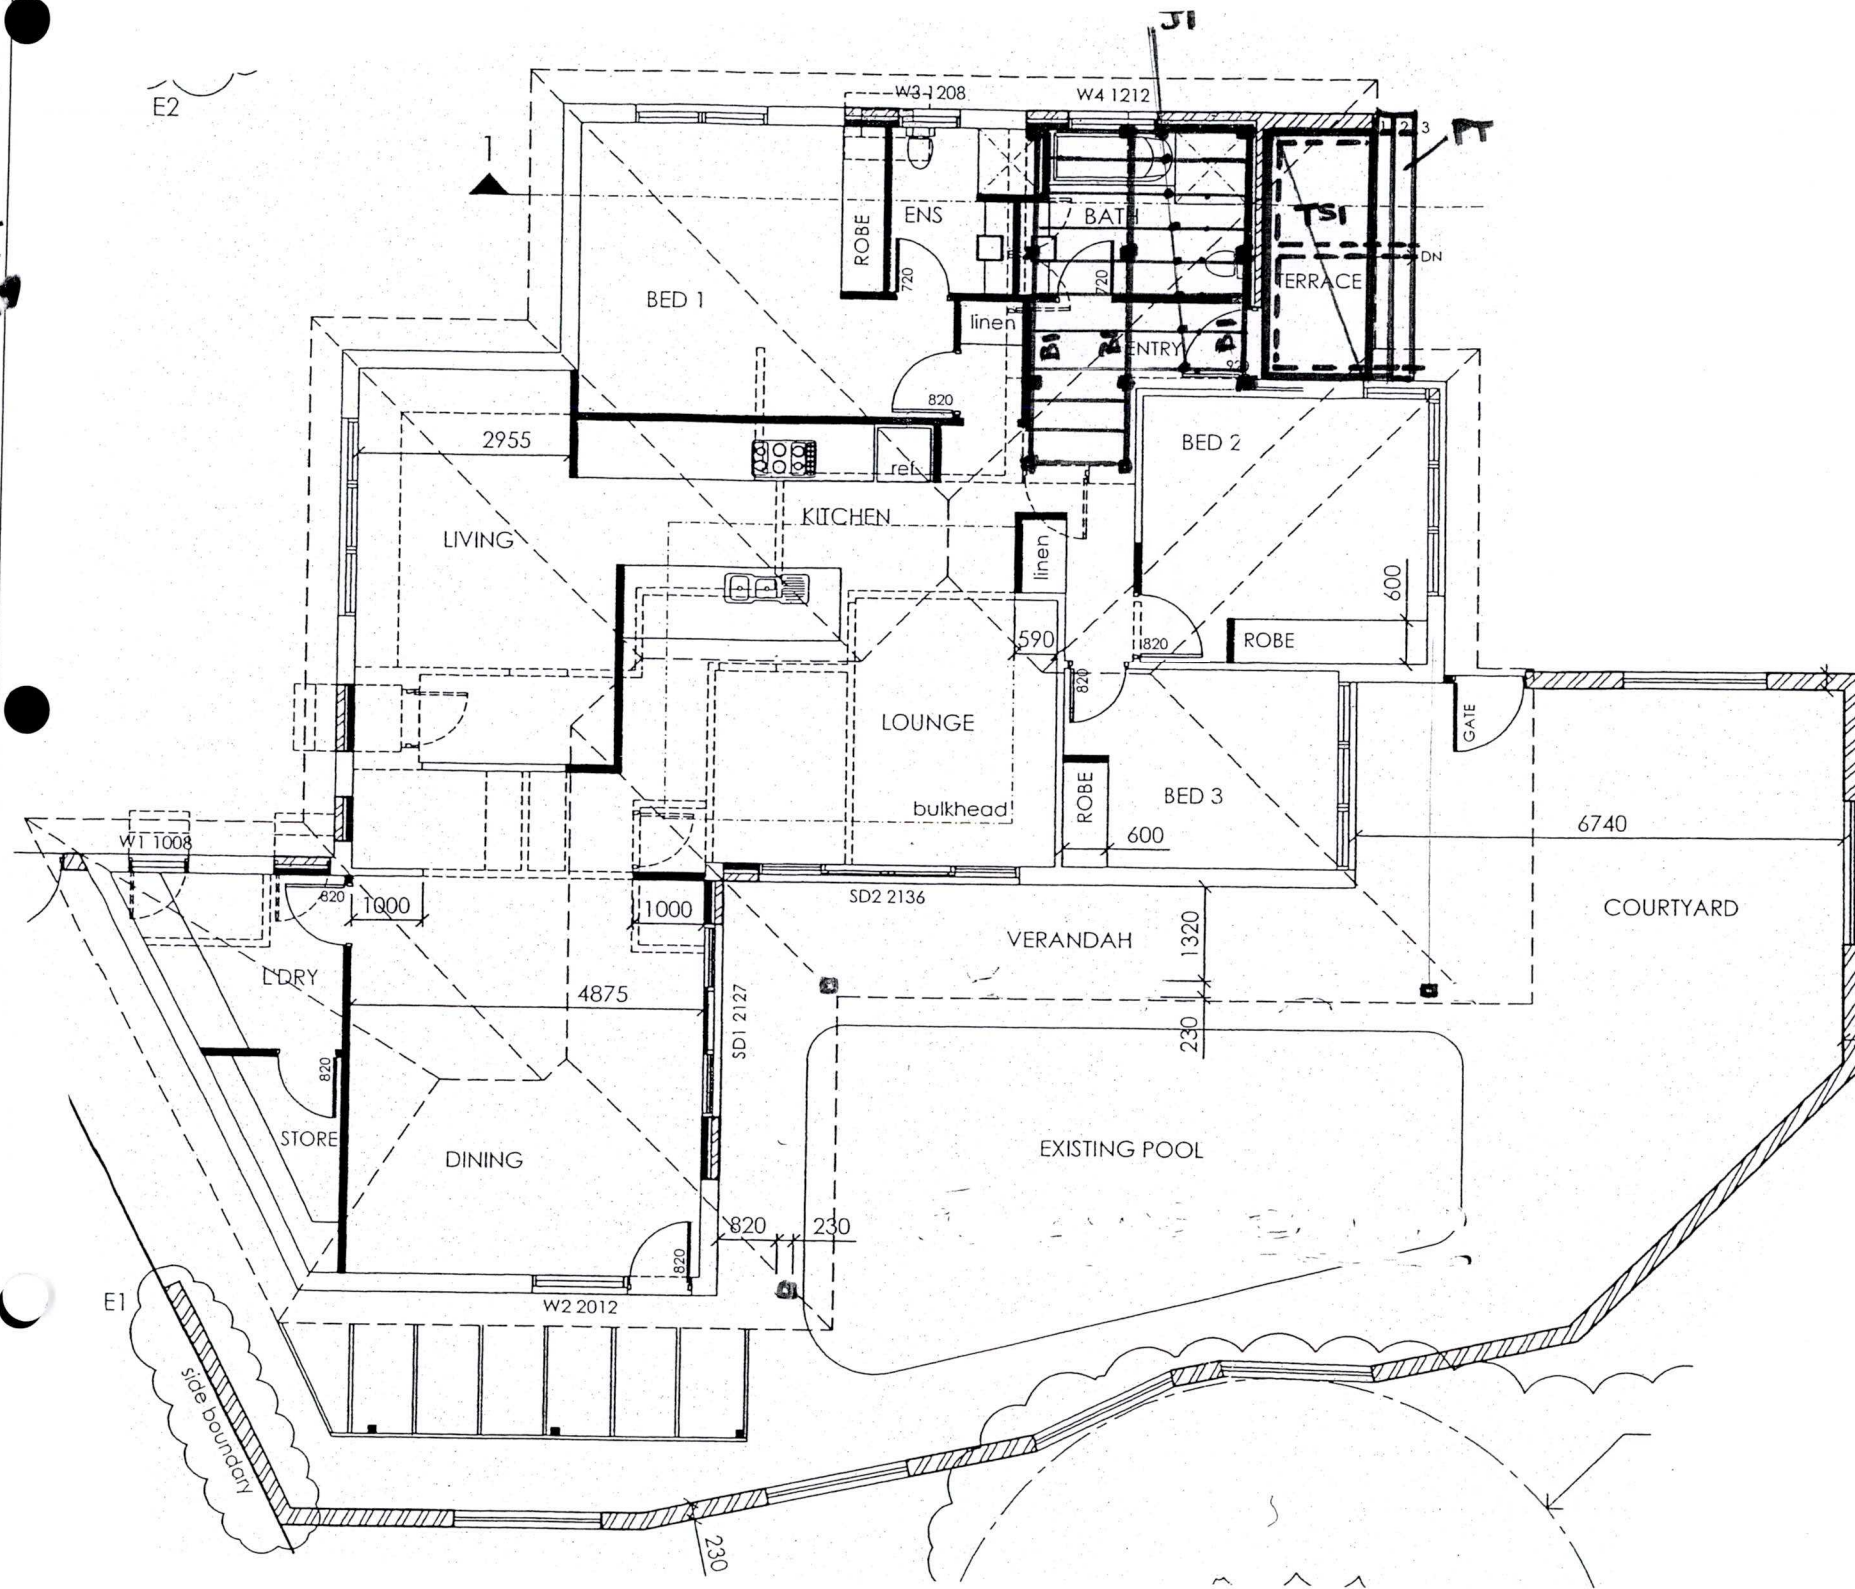
**FLOOR & SLAB PLAN**

**FLOOR FRAMING**

- All strip footings to be SF1 unless otherwise noted
  - SF1 500mm deep x 300mm wide, reinforced with 3-L11TM top & bottom
  - SF2 400mm deep x 450mm wide, reinforced with 4-L11TM top & bottom

- Where new footing abuts existing footing drill and grout 2N16 dowels x 400mm long at least 100mm into existing. Noted \* on plan.
- Pad footings "P1" for floor framing to be 450mm square mass concrete or 450 diameter bored piers founded 650mm into natural ground.
- Pad footings for verandah columns "P2" to be 400mm bored piers carried down to 300mm below in invert level of the pool. Reinforce piers with 4N12 bars and R6 ligatures at 450mm ccs, 75 cover.
- Concrete to footings grade N25. Concrete for blinding under footings if required to be grade N10. Concrete to footings to be adequately vibrated in accordance with AS2870.
- No walls are to act as retaining walls unless constructed in accordance with the detail of the typical masonry gravity or random rock retaining walls.

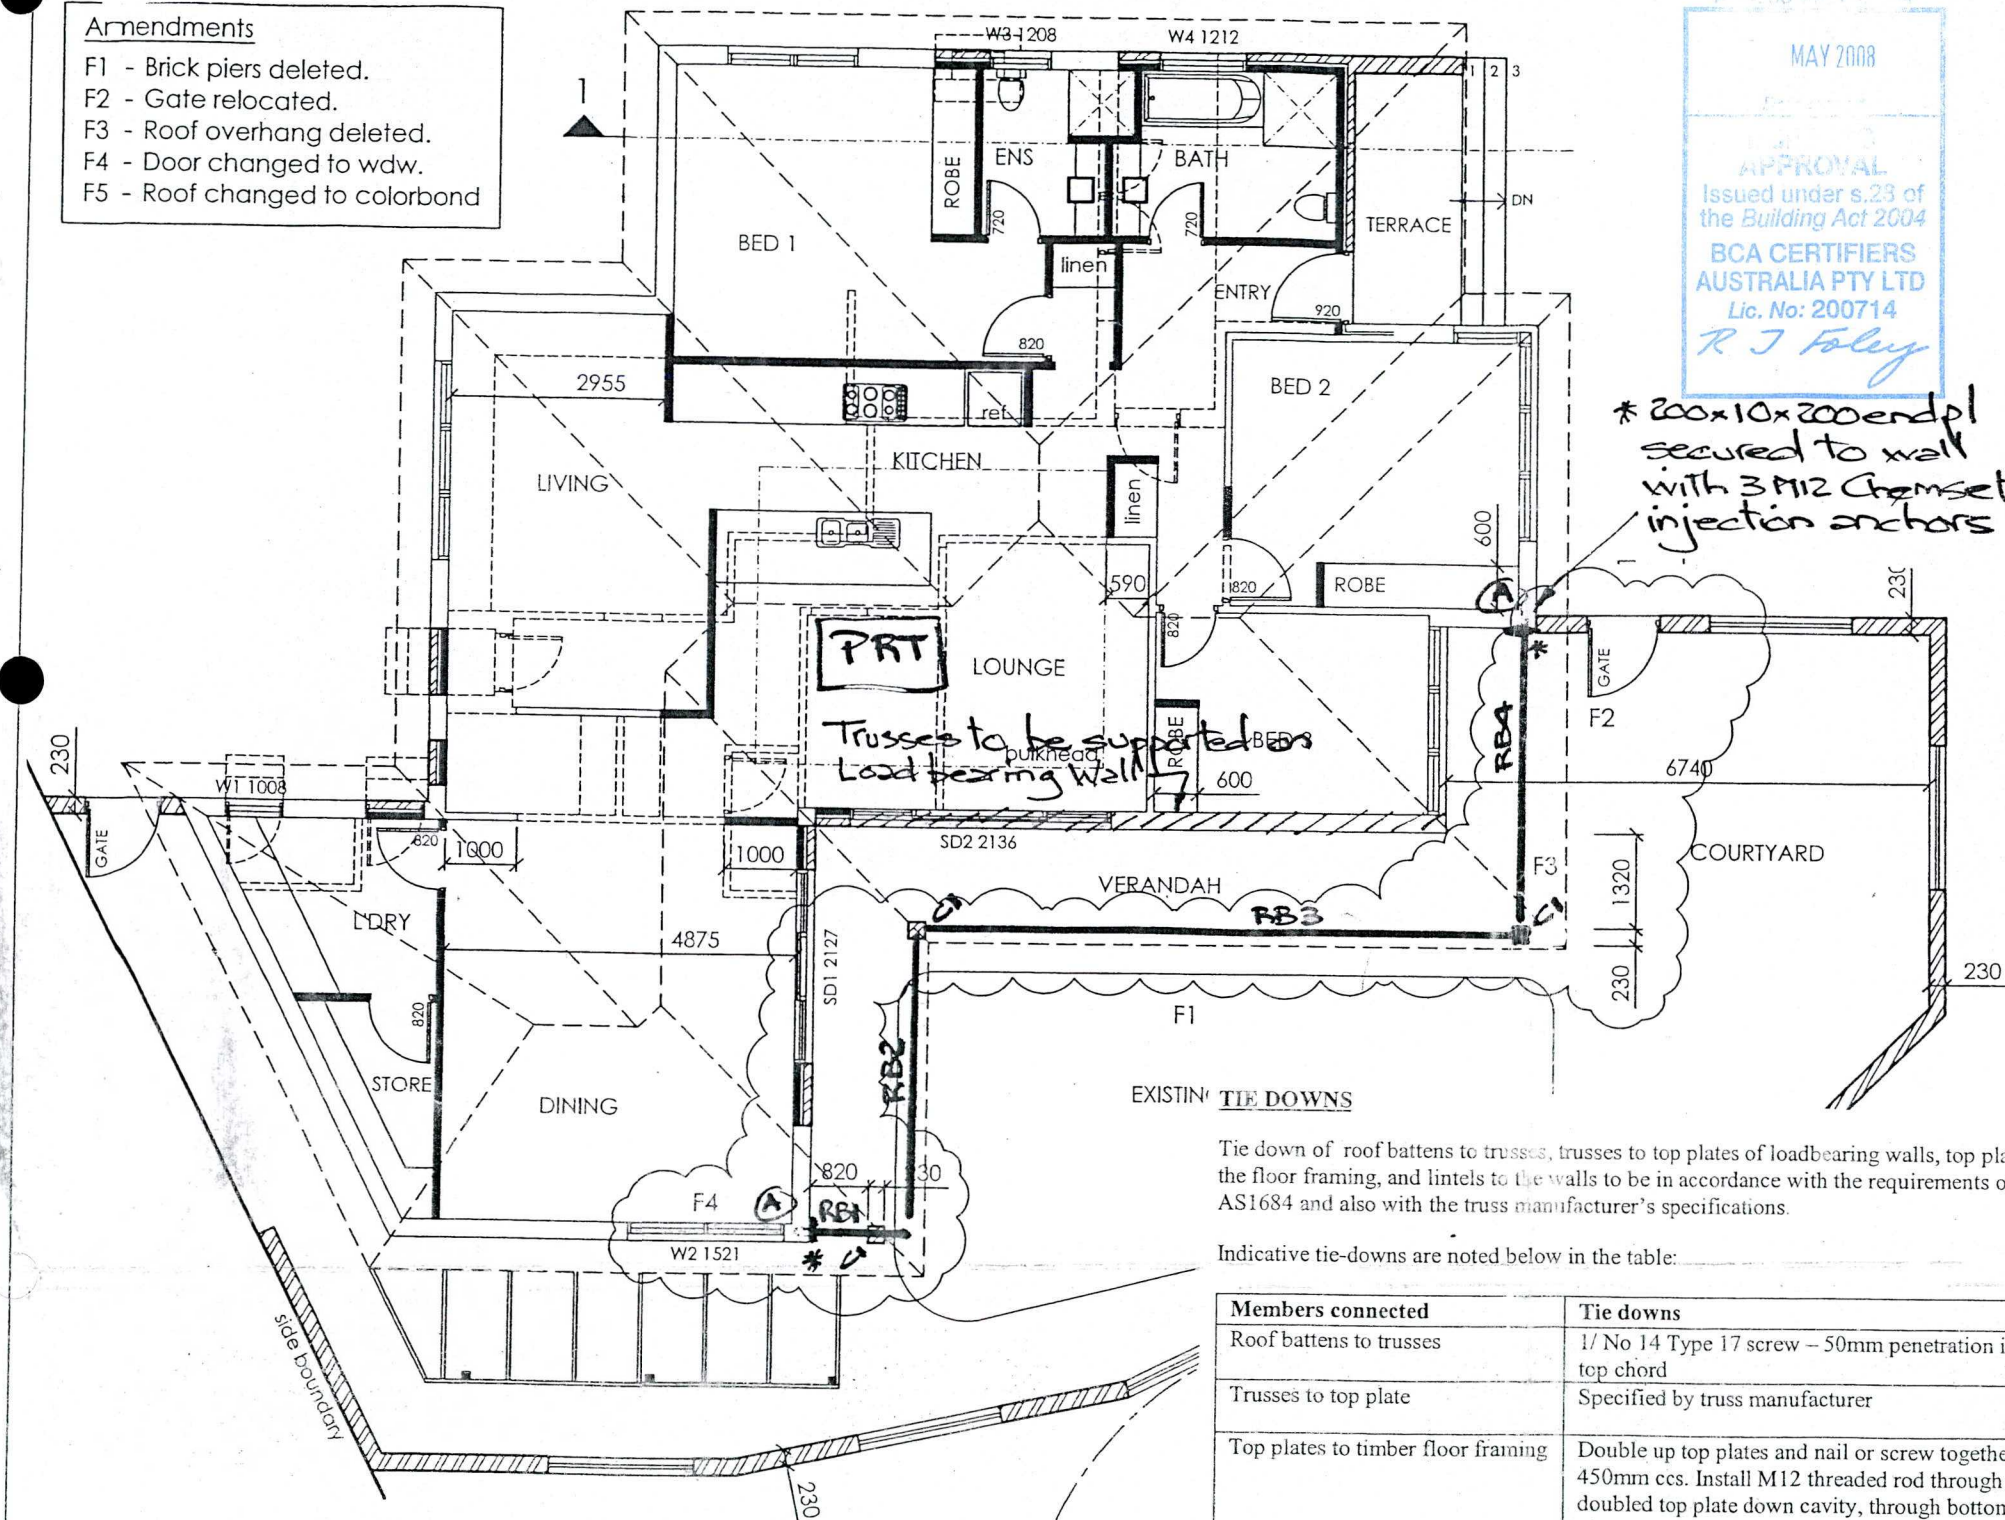
## ROOF FRAMING PLAN

\* 200x10x200 end pl secured to wall with 3 M12 Chemset injection anchors

- The builder shall be responsible for maintaining the new roof and remaining walls in a stable condition at all times during the construction work.
- The builder shall notify the engineer if any additional roof beams that are required once the truss manufacturer designs the trusses. Design, configuration, erection, tie downs and bracing of the trusses shall accord with the requirements of the truss manufacturer's specifications and also AS1684 & A4440 - Installation of gang-nail timber trusses.

- Because the tiled clad cut roof is being removed and replaced with proprietary timber roof trusses and a metal deck roof, the supporting stud walls will not be compliant with the tie-down requirements of the BCA. We therefore have to provide anchorage of the top plate down to the floor framing so that it can accommodate the uplift loads imposed upon the roof. Refer to details of the required anchorage.

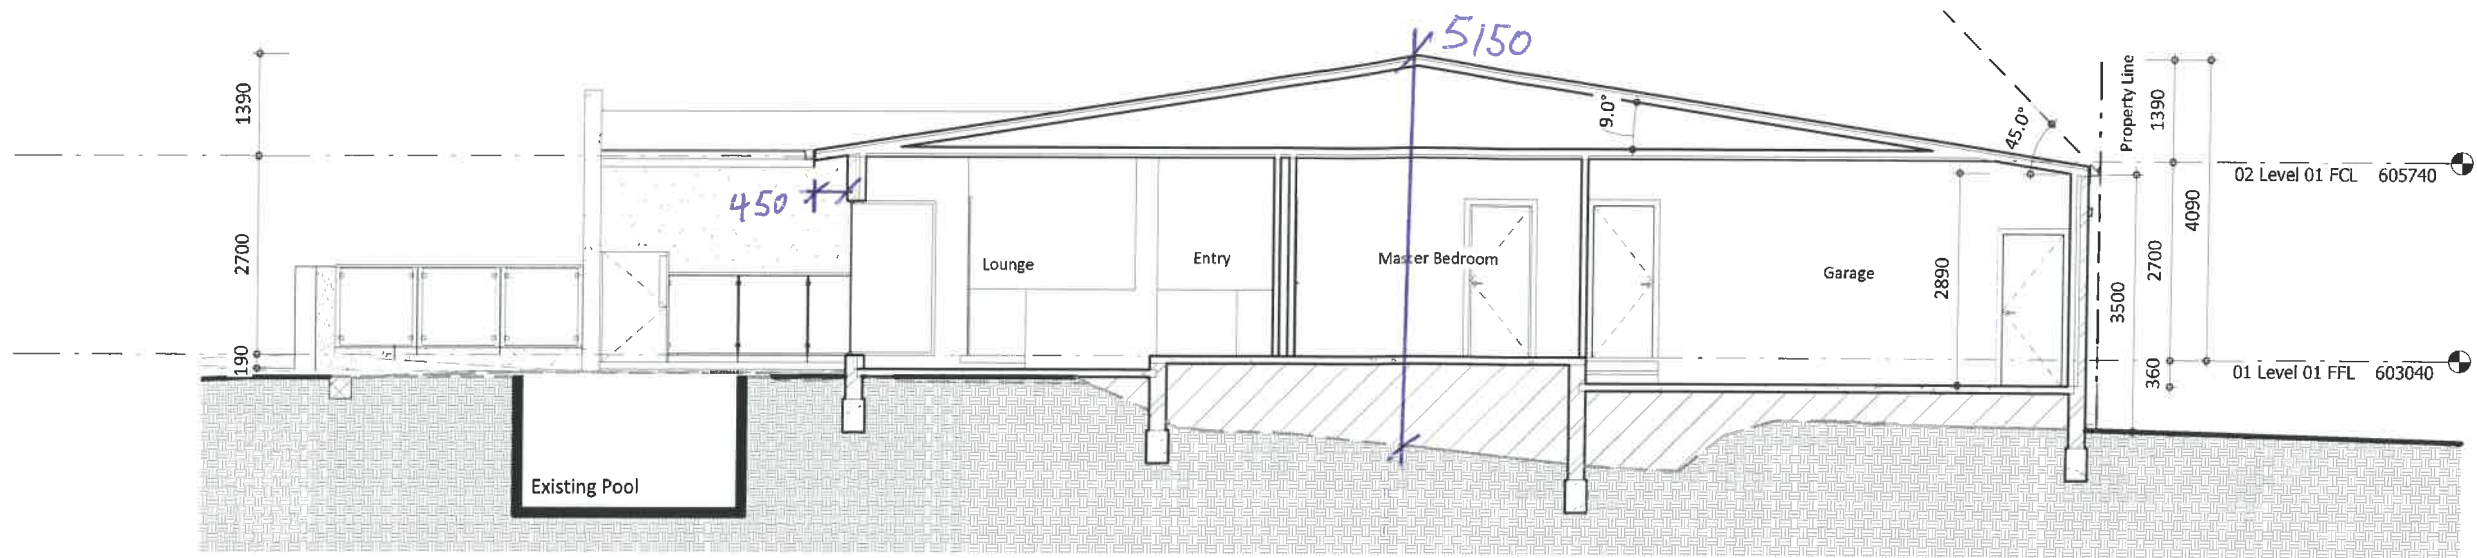
# 1 Section 1 1:100

**Floor Insulation:**  
Floor construction to be as noted in Section drawing.

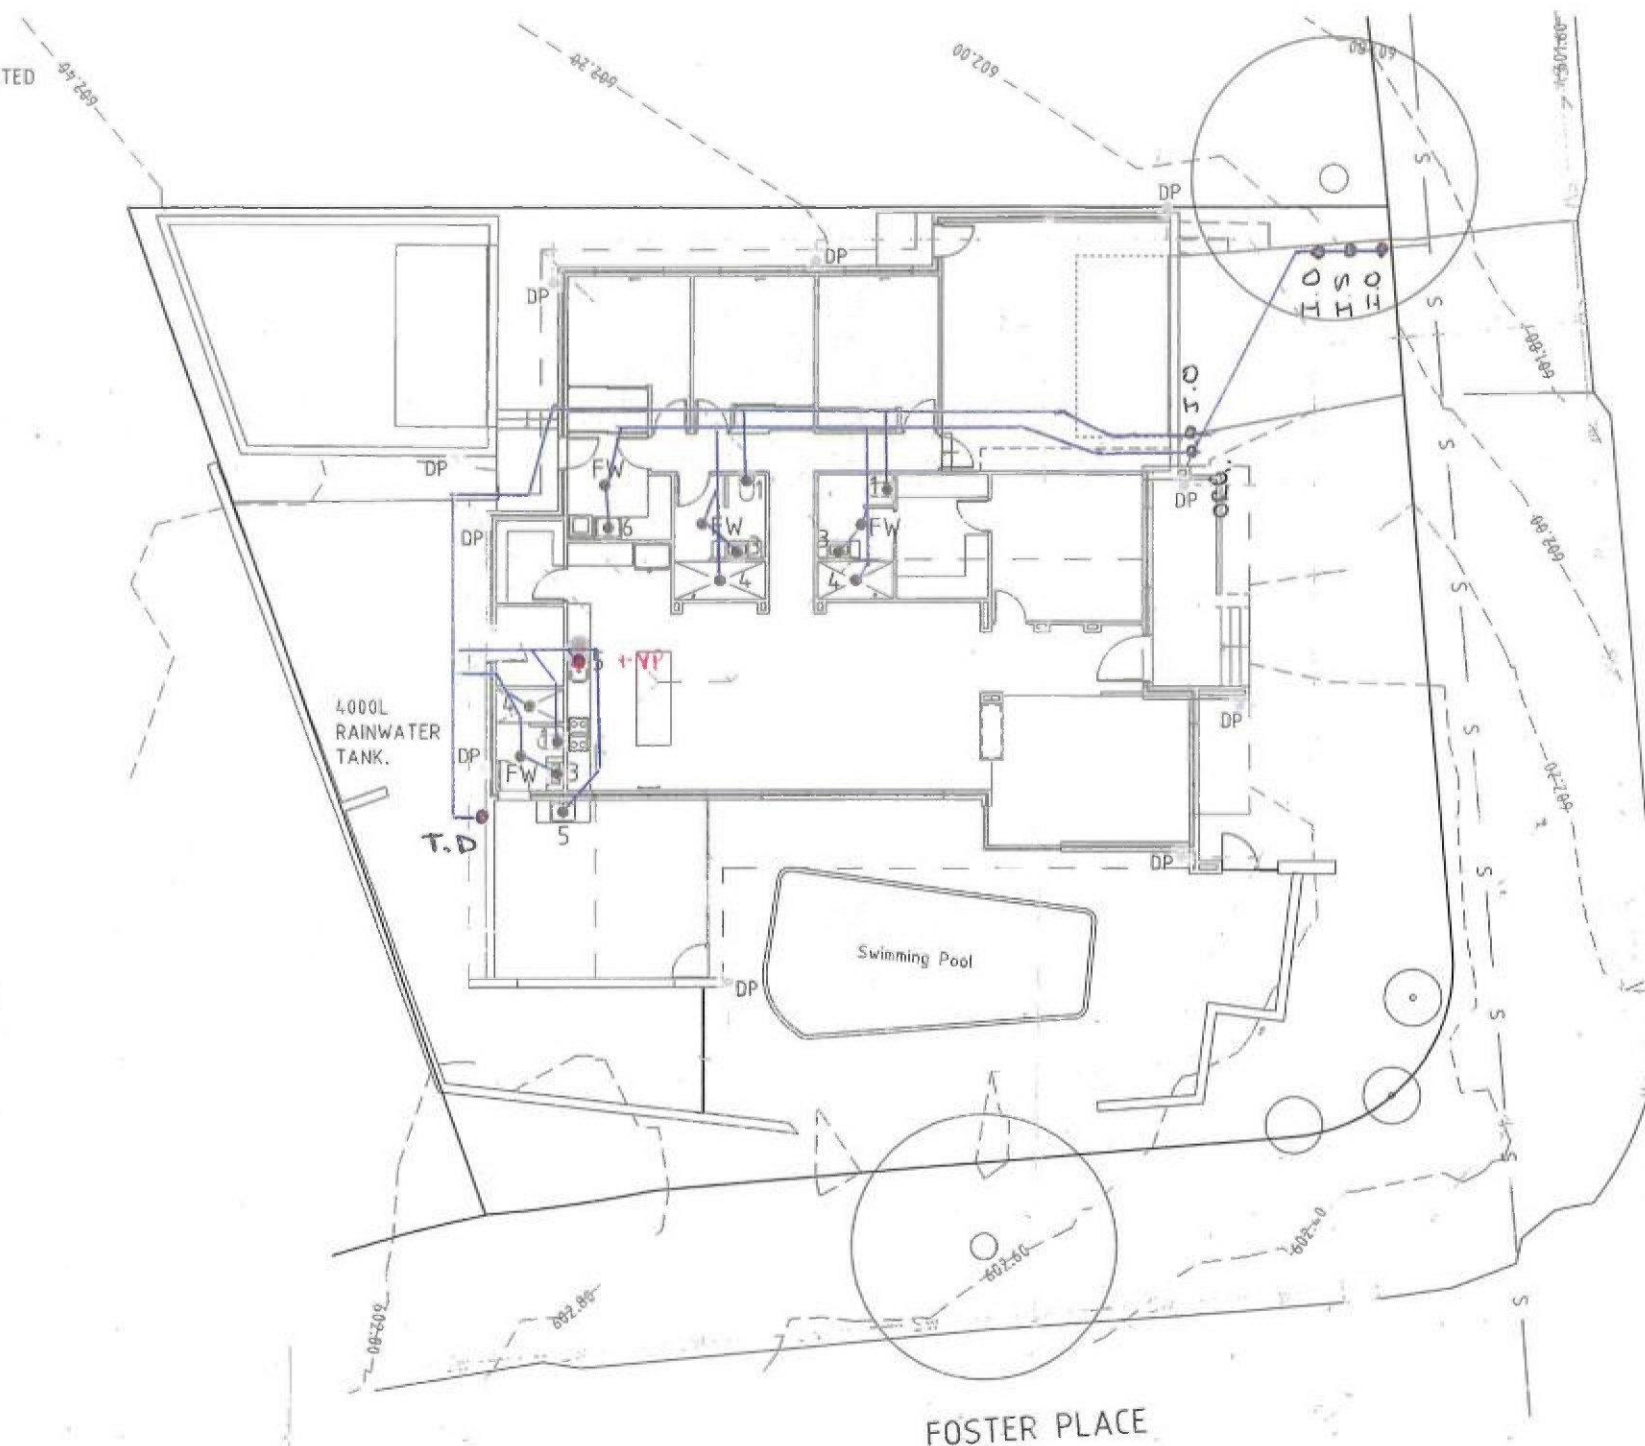
SEWER  
TIE : 1.1m  
DEPTH: 1.4m

STORMWATER  
TIE : 3.5m  
DEPTH: 1.1m
