Report

Building Report

Property Address: 14 Chermshire St, Deakin ACT 2600
Client: Clarke
Inspection Date: Tuesday, June 9th 2026
Inspection carried out by: Michael Robinson

PROPOSED RESIDENCE ON BLOCK 5. SECTION 15. DEAKIN CANBERRA.

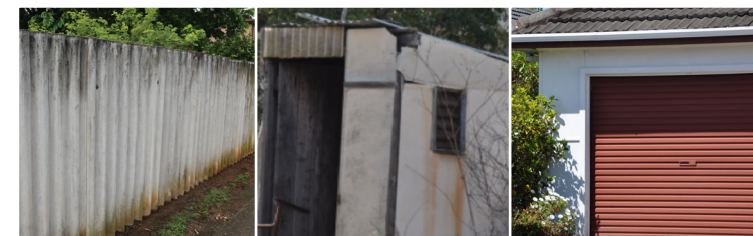
- 4.** Backyard
fences, sheds, garages, carports, dog kennels, buried or
dumped waste, letterboxes, swimming pools
