# Report

# Building Report

## CONCLUSION AND SUMMARY

# Timber Pest Report

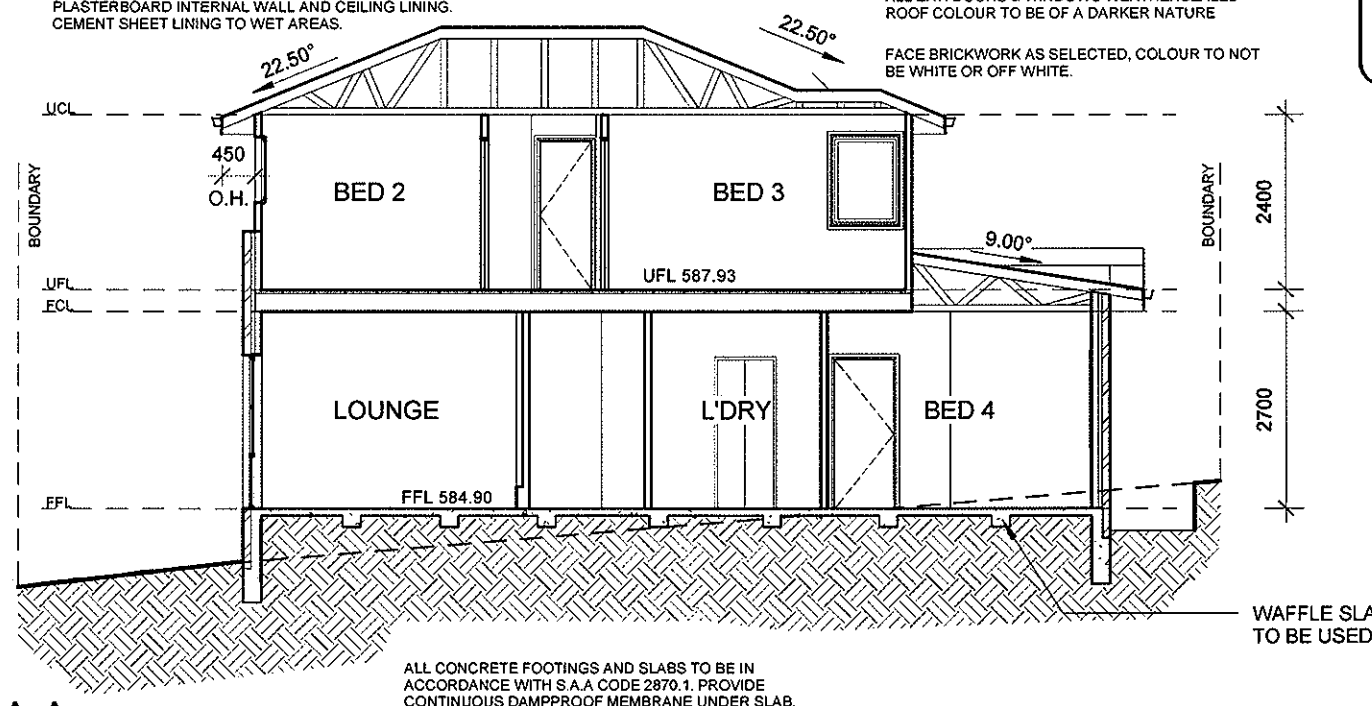
SECTION A-A

ALL CONCRETE FOOTINGS AND SLABS TO BE IN  
 ACCORDANCE WITH S.A.A CODE 2870.1. PROVIDE  
 CONTINUOUS DAMPPROOF MEMBRANE UNDER SLAB.

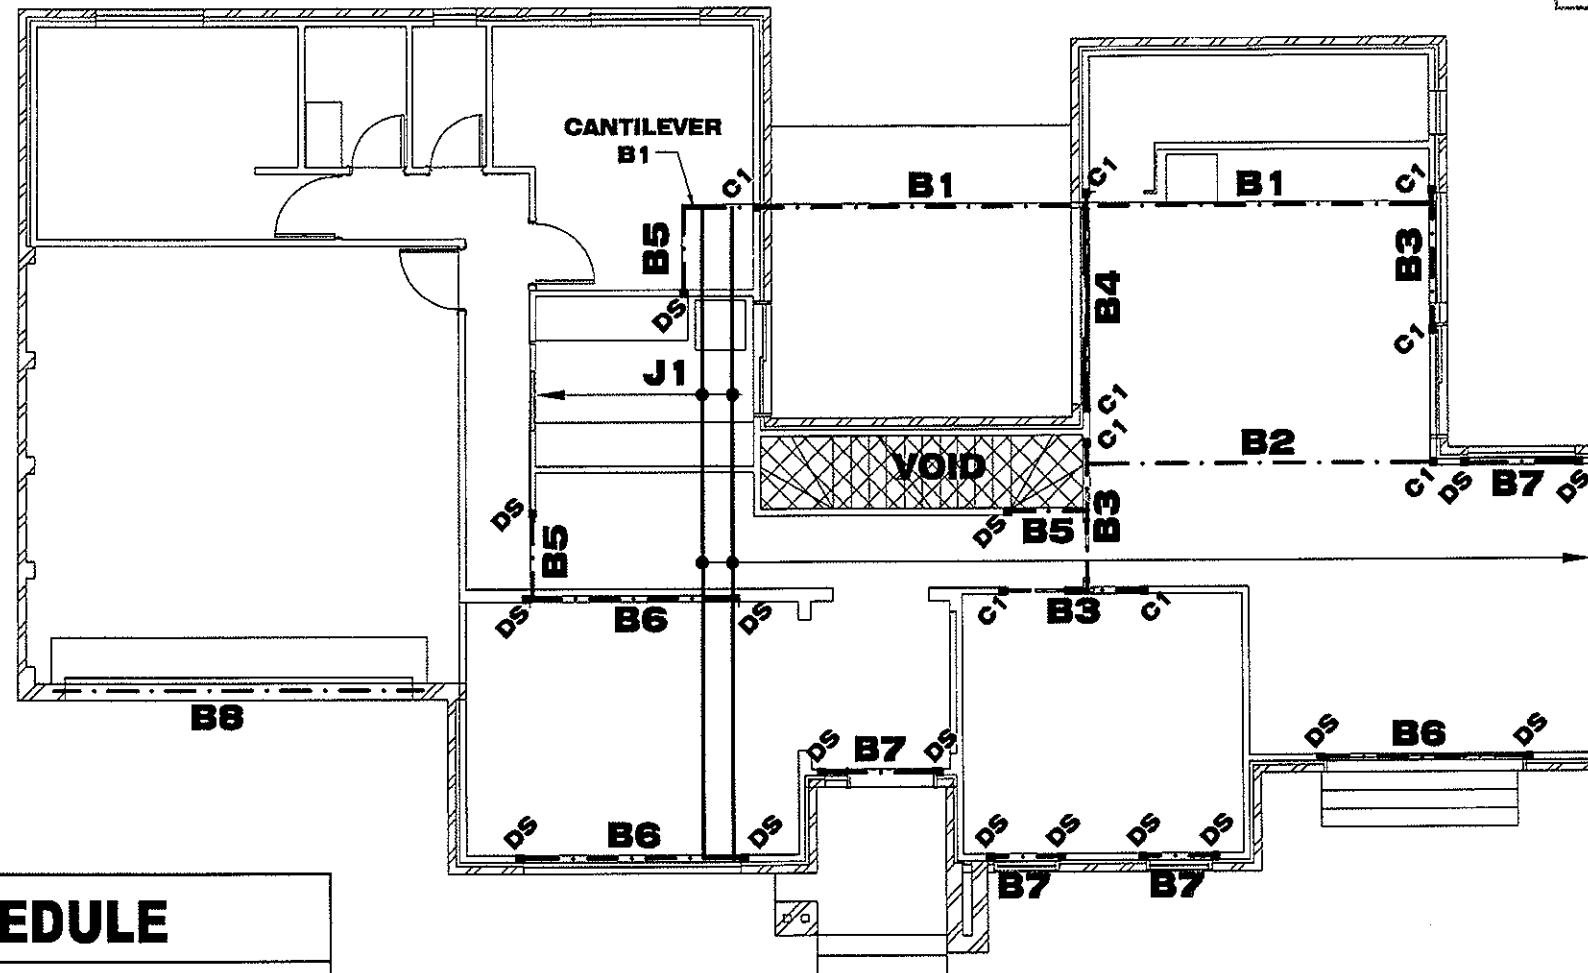
**JOIST & BEAM LAYOUT**  
SCALE = 1 : 100

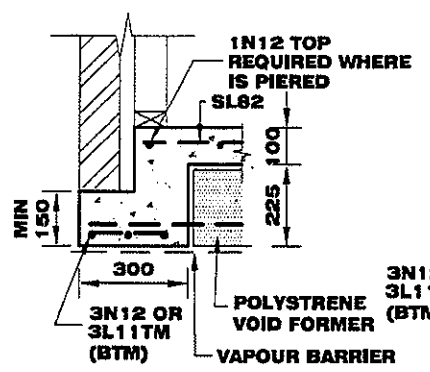
BEARING ONTO NATURAL STRATA OR PIERS(SEE NOTES)  
**STANDARD EDGE BEAM EB1**  
**SECTION A**  
 SCALE = 1:20

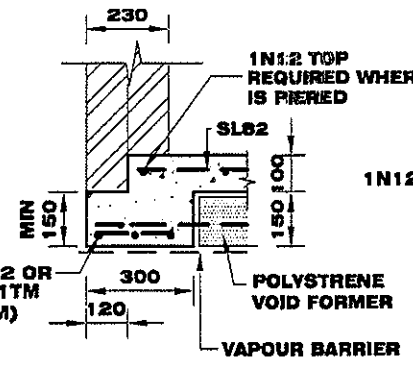
BEARING ONTO NATURAL STRATA OR PIERS(SEE NOTES)  
**STANDARD EDGE BEAM EB2**  
**SECTION B**  
 SCALE = 1:20

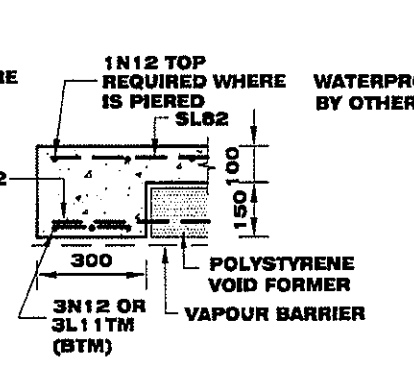
BEARING ONTO NATURAL STRATA OR PIERS(SEE NOTES)  
**STANDARD EDGE BEAM EB3**  
**SECTION C**  
 SCALE = 1:20

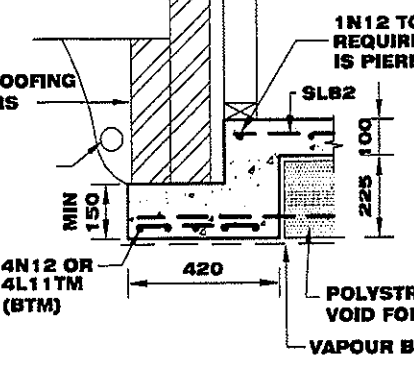
BEARING ONTO NATURAL STRATA OR PIERS(SEE NOTES)  
**STANDARD EDGE BEAM EB4**  
**SECTION D**  
 SCALE = 1:20

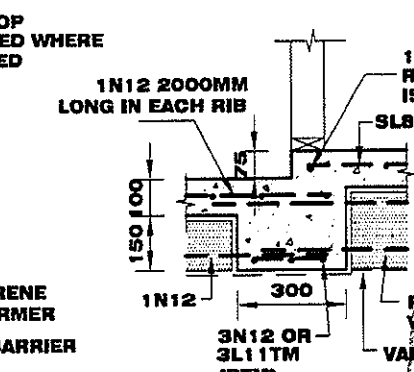
BEARING ONTO NATURAL STRATA OR PIERS(SEE NOTES)  
**75mm STEPDOWN BEAM SD1**  
**SECTION E**  
 SCALE = 1:20

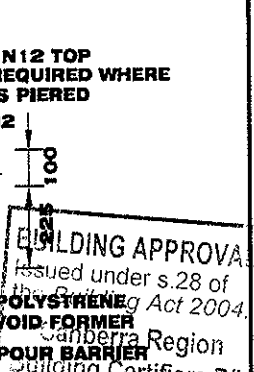
BEARING ONTO NATURAL STRATA OR PIERS(SEE NOTES)  
**STANDARD SLAB THICKENING ST**  
**SECTION F**  
 SCALE = 1:20

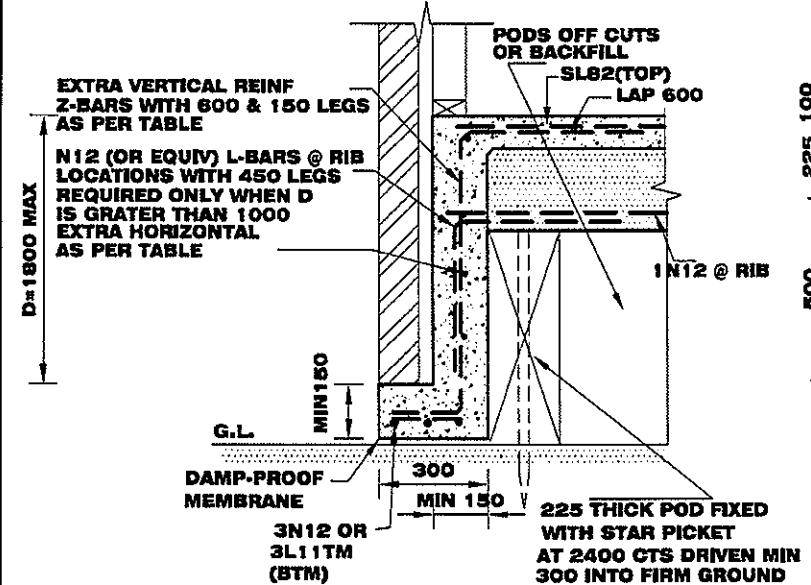
BEARING ONTO NATURAL STRATA OR PIERS(SEE NOTES)  
**DEEP EDGE BEAM (1800 MAX)**  
 SCALE = 1:20

| EXTRA REINFORCEMENT TO DEEP EDGE & DEEP STEP BEAM | | |

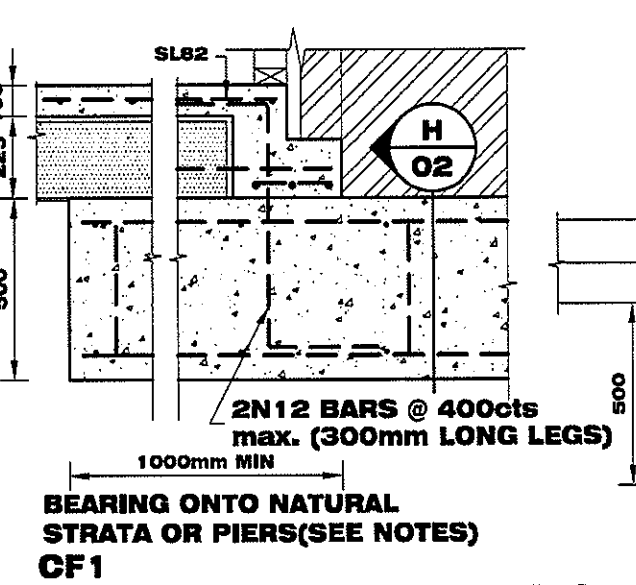
BEARING ONTO NATURAL STRATA OR PIERS(SEE NOTES)  
**CF1 TYPICAL CANTILEVED FOOTING**  
 SCALE = 1:20

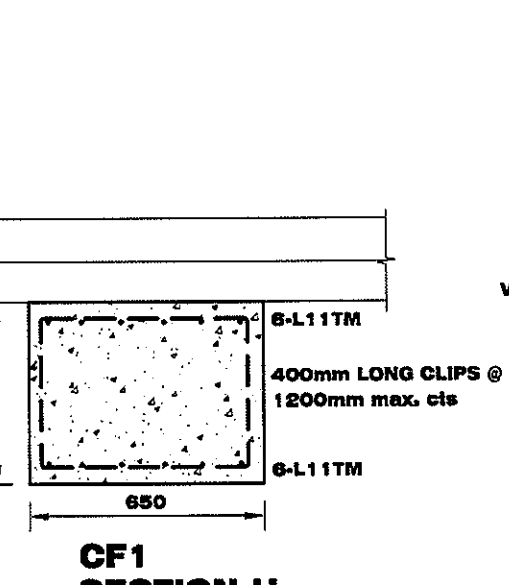
**CF1 SECTION H**  
 SCALE = 1:20

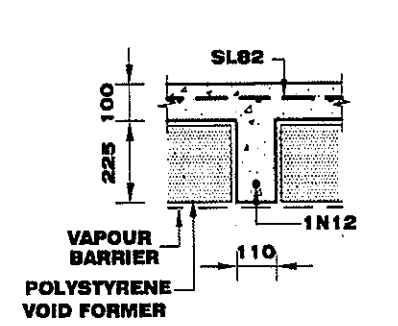
**STANDARD INTERNAL RIB (GARAGE SIMILAR)**  
 SCALE = 1:20

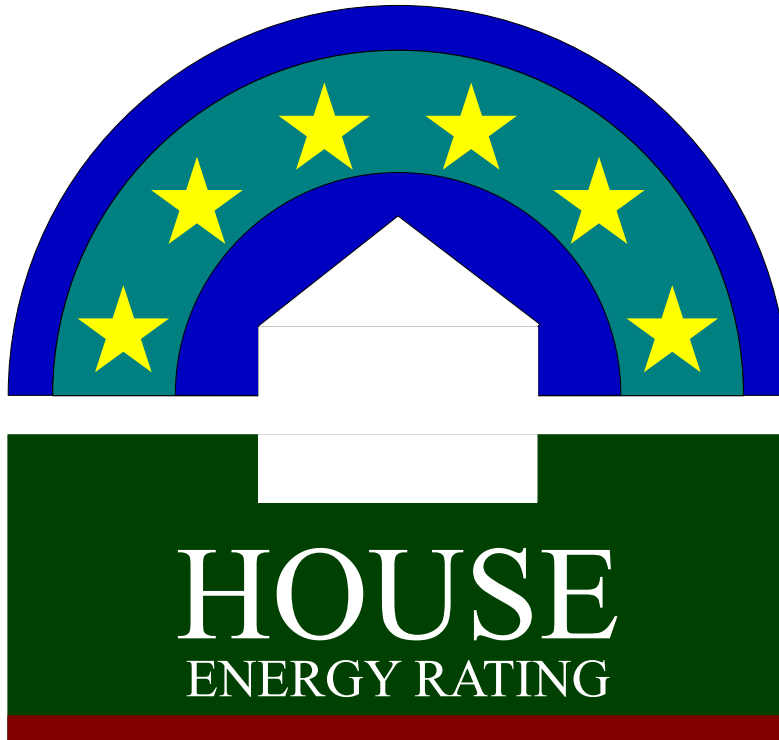
**YOUR HOUSE ENERGY RATING IS:** ★★ ★★ ★★ ★★ ★★ **6 STARS**  
**in Climate: 24** **SCORE: 21 POINTS**
