Building Report

CONCLUSION AND SUMMARY

Timber Pest Report

Compliance Report

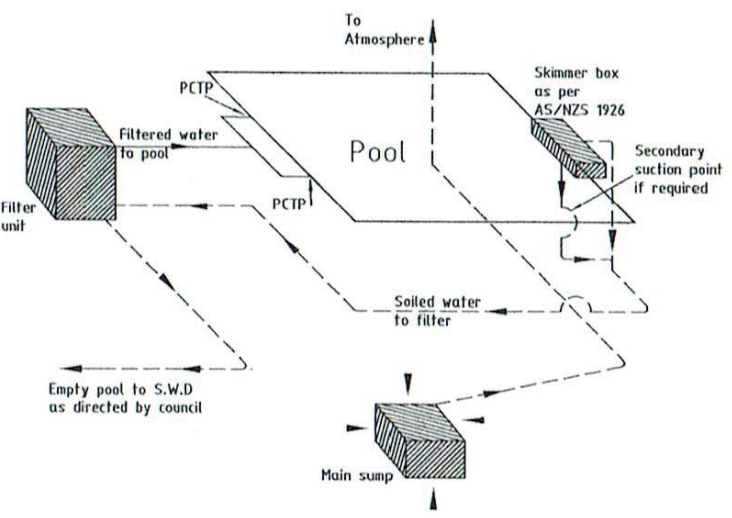
WATER RETICULATION FLOW DIAGRAM
N.T.S.
ALL FILTRATION PIPES TO BE 40mm (min) PVC CLASS 9 PIPES AND ALL FITTINGS CLASS 18.
