# Residential REPORTS

## PRESALE REPORT

**3 Scott Street**

Narrabundah

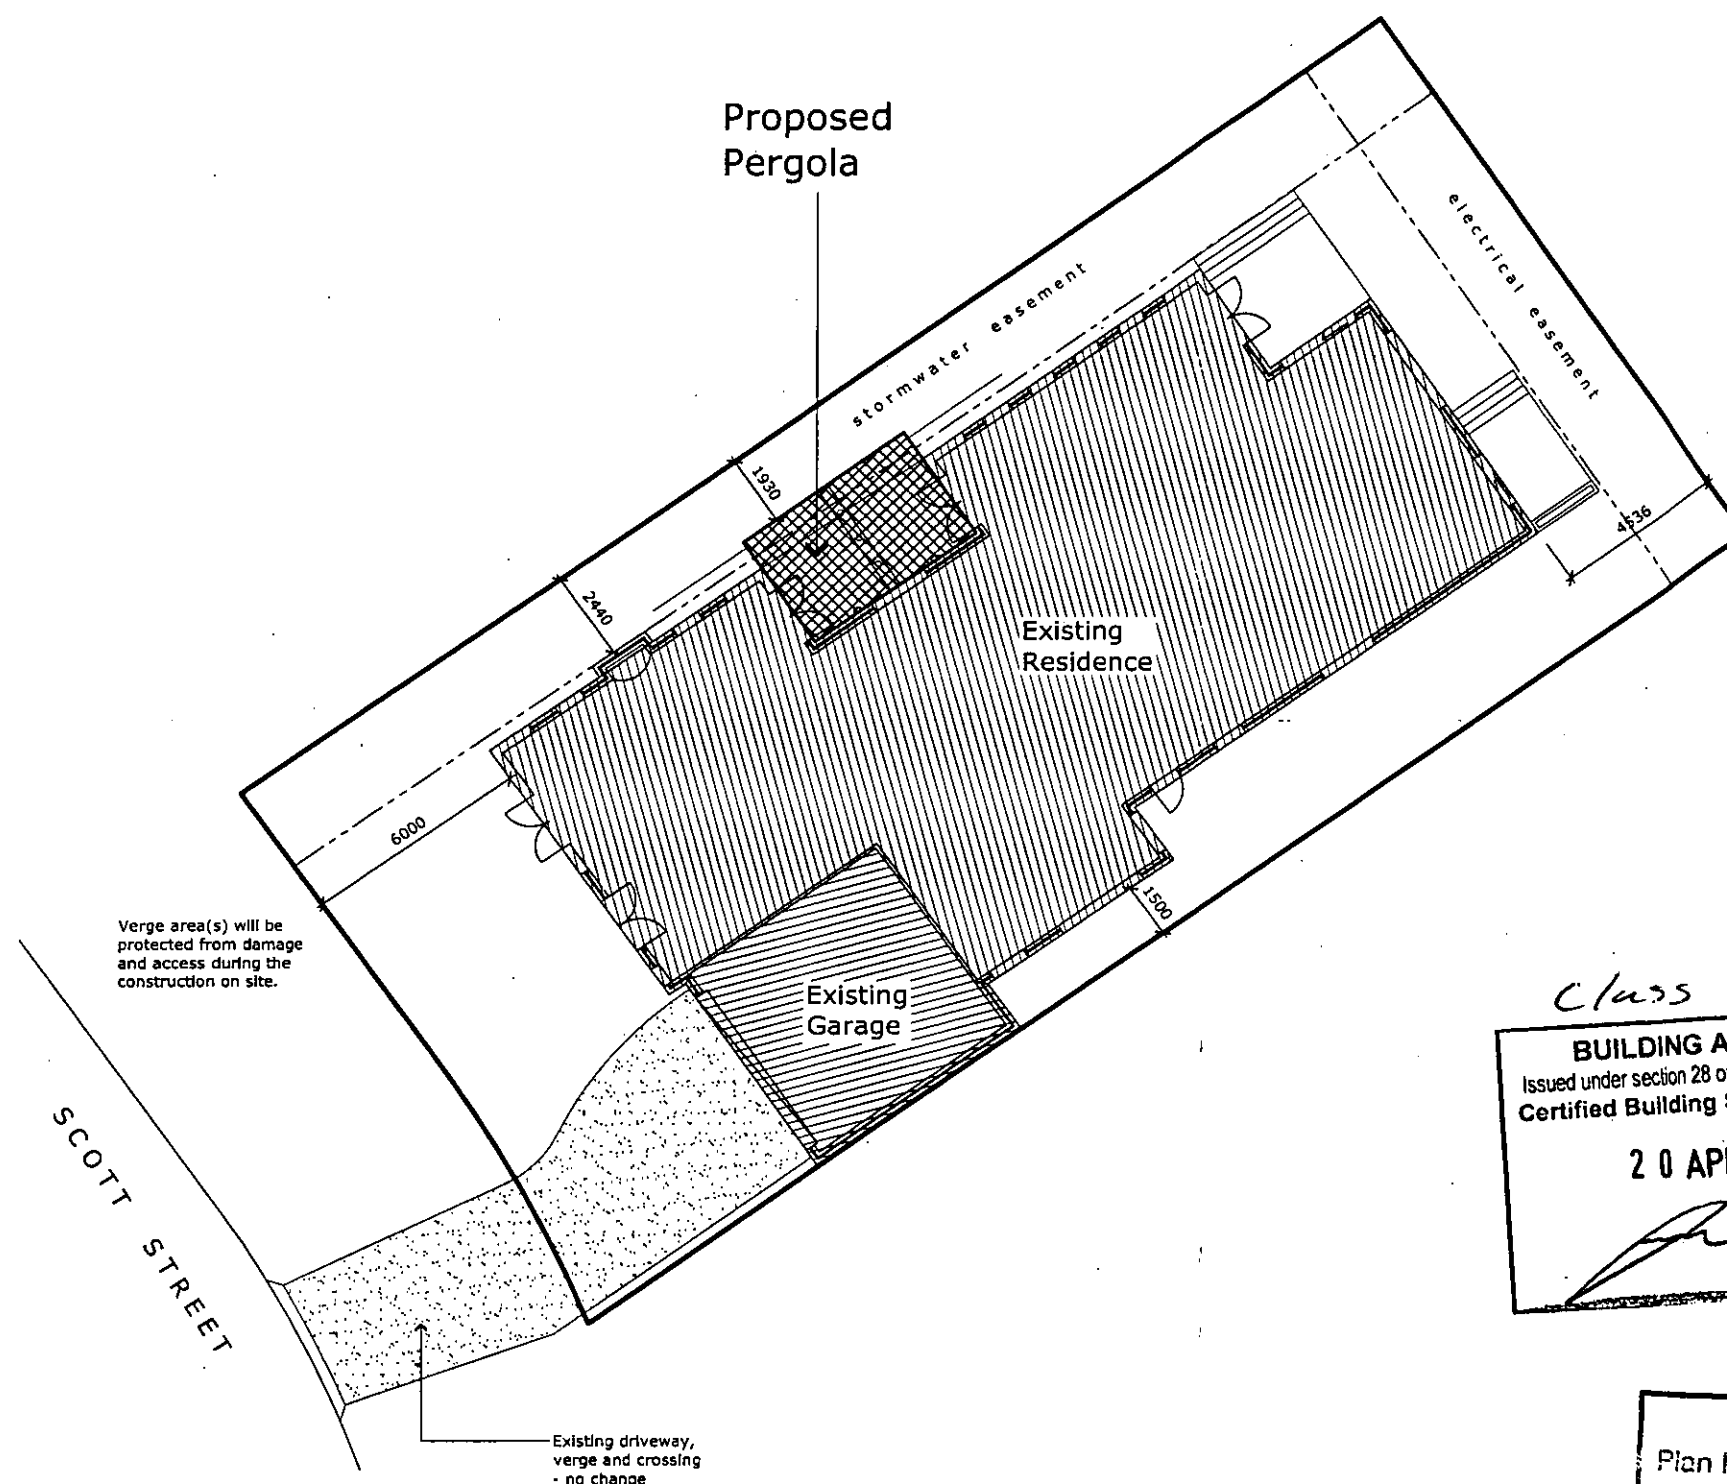
SITE PLAN

- 1 Proposed 2 bay open / close roof system as shown
- 2 Pergola height to be clear of 2 x existing 3020mm high downpipes
- 3 Pergola to be anchored entirely to 3 x existing residence walls / no posts required.
- 4 Framing to be steel
- 5 3 x downlights to be provided and installed down centre of pergola as shown and as indicated by the following symbol

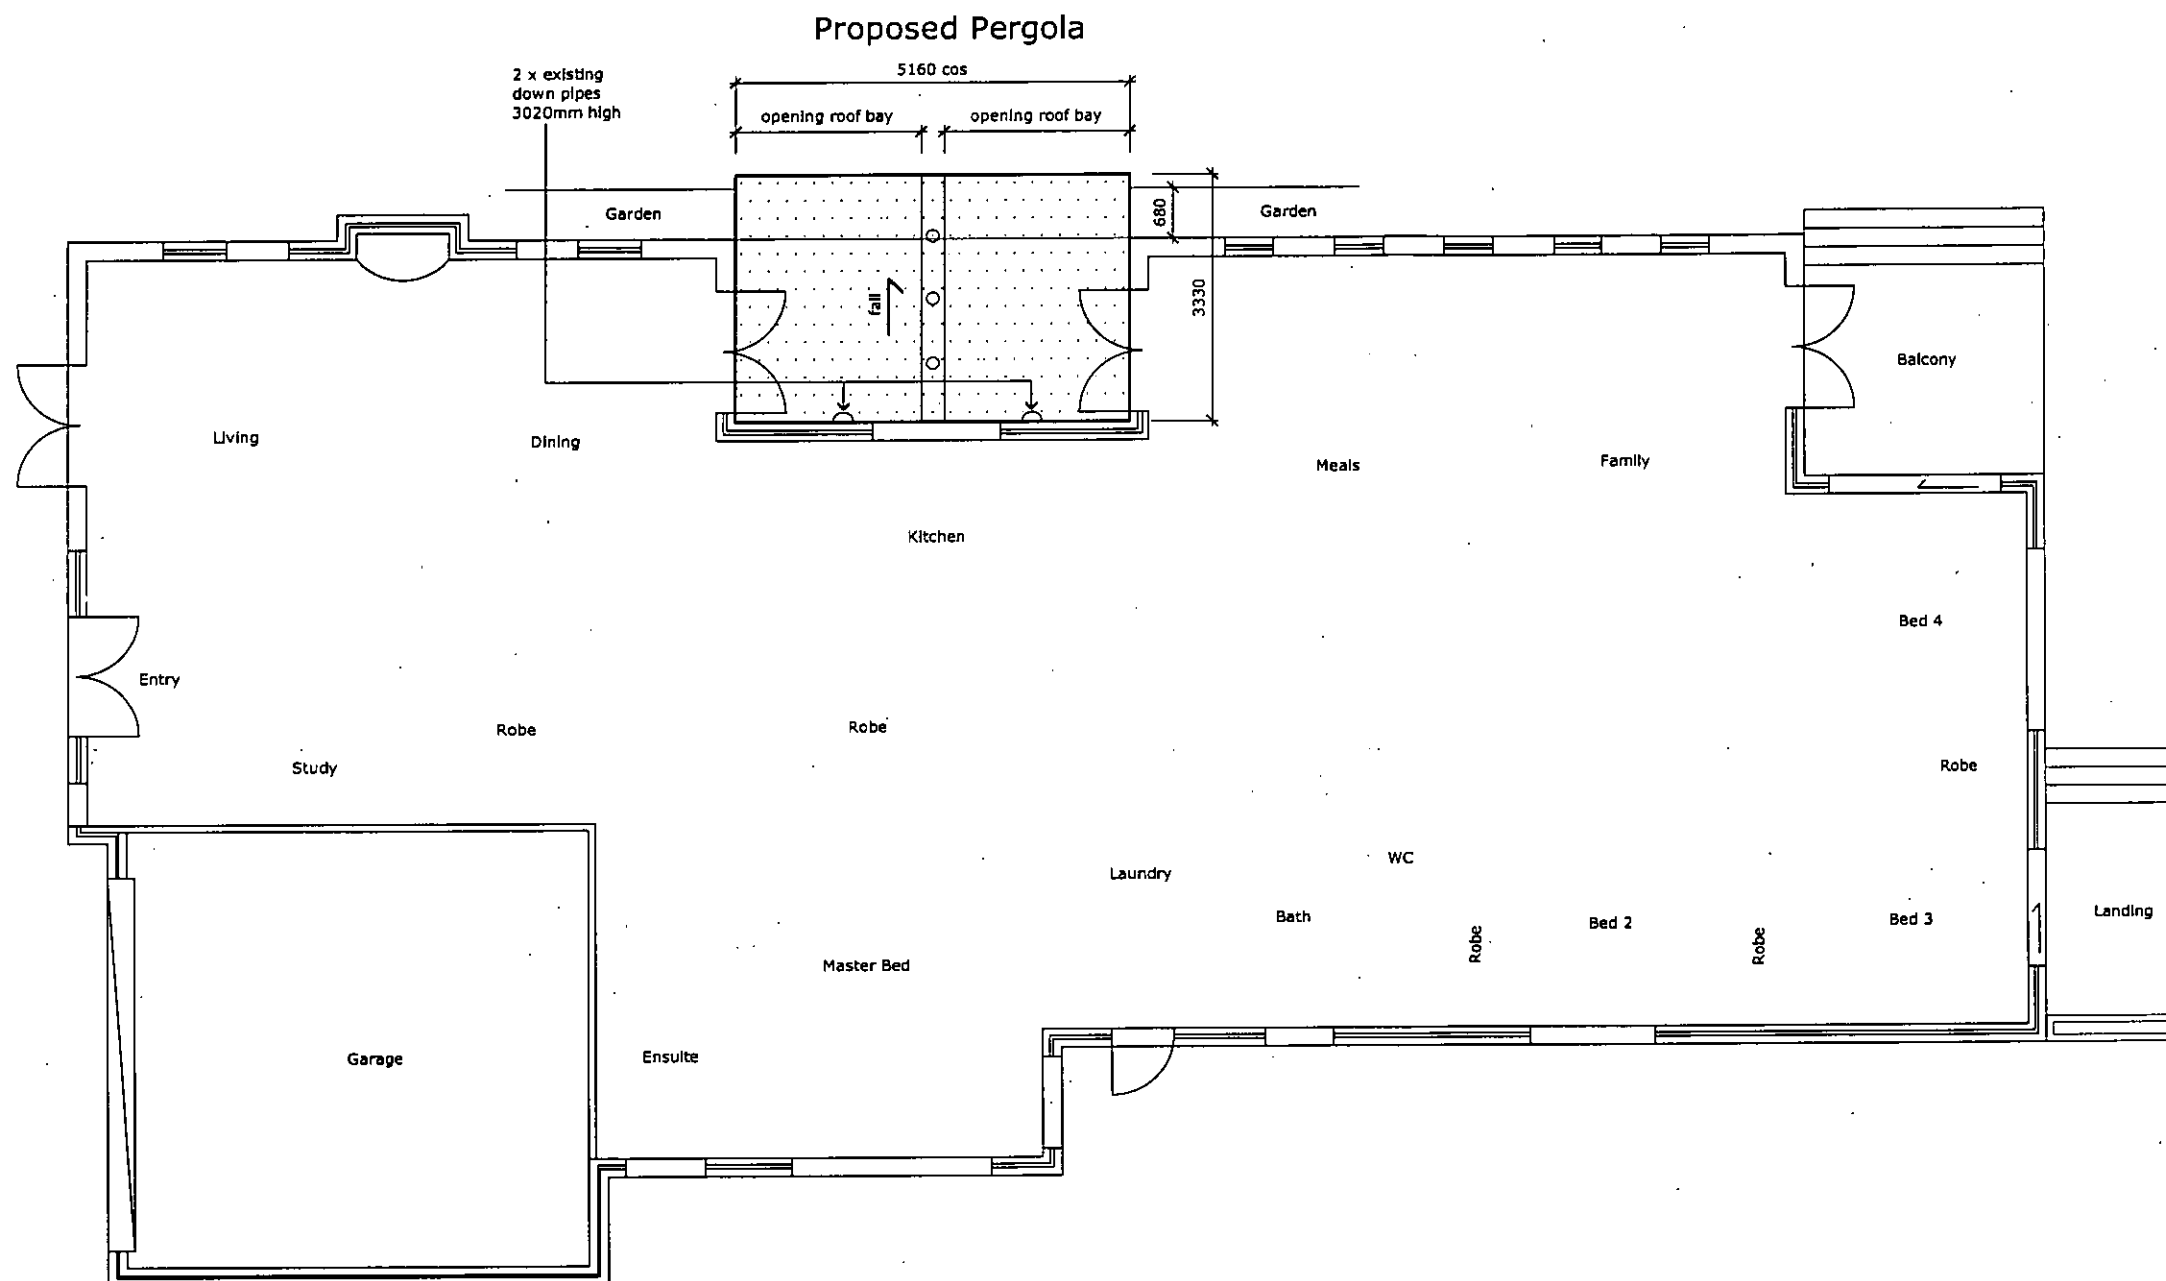
FLOOR PLAN - for public register

- 1 Proposed 2 bay open / close roof system as shown
- 2 Pergola height to be clear of 2 x existing 3020mm high downpipes
- 3 Pergola to be anchored entirely to 3 x existing residence walls / no posts required.
- 4 Framing to be steel
- 5 3 x downlights to be provided and installed down centre of pergola as shown and as indicated by the following symbol
