# Report

# Building Report

## CONCLUSION AND SUMMARY

PROJECT	NEW RESIDENCE	
CLIENT	V. & D. MILIC	
BLOCK SECTION SUBURB	10 3	NARRABUNDAH
DRAWING TITLE	FLOOR PLAN	
DATE	SCALE	DRAWN
SEP.98	1:100	AH CAD
JOB NO.	DWG NO.	CODE
9832	A02	B

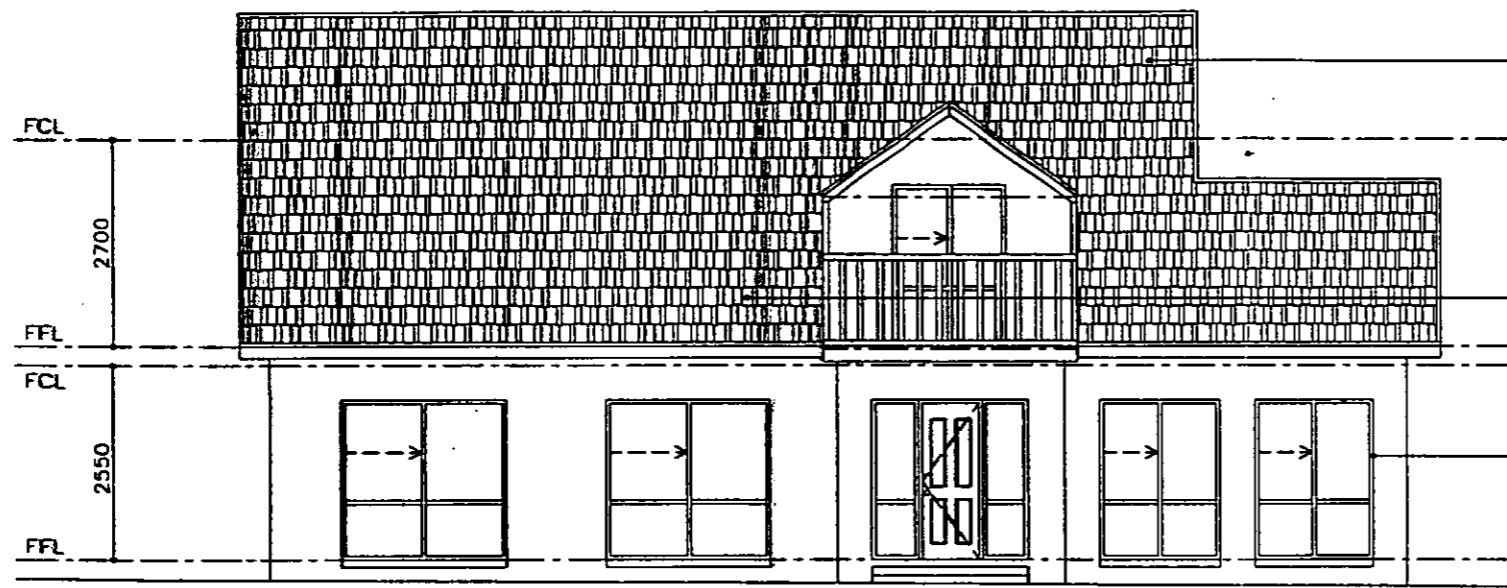
1 NORTH ELEVATION  
- 1:100

CONCRETE ROOF TILES

200x45 OREGON RAFTERS

TIMBER FRAMED WINDOWS AS PER MANUFACTURERS DETAILS

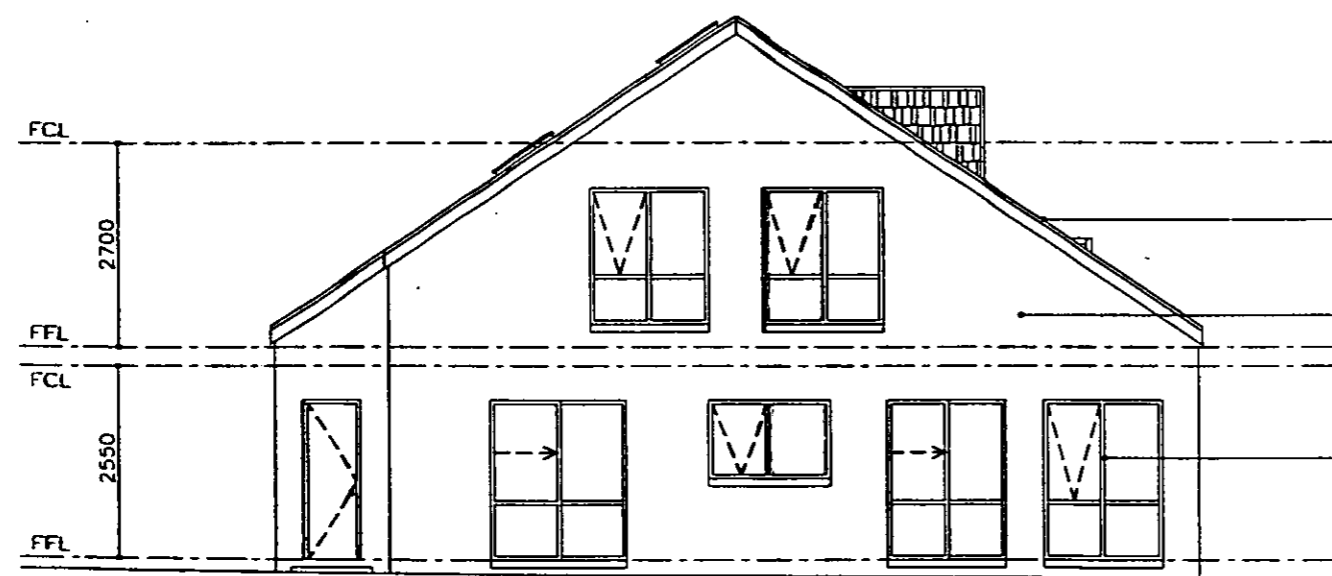
35 DEGREE ROOF PITCH

250mm BRICK VENEER WALL WITH R2 INSULATION AND RENDERED FINISH
