Building Report  
Timber Pest Inspection Report  
Compliance Report  
Conveyancing Report  
Energy Efficiency Rating  
Insurance Certificates  
Tax Invoice

# Building Report

ARGYLE SQUARE, REID  
132 TOWNHOUSES  
SECTION 8 REID ACT. 7  
BY R & B CONSTRUCTIONS  
7 BALANU PL GIRALANG ACT 41 2850

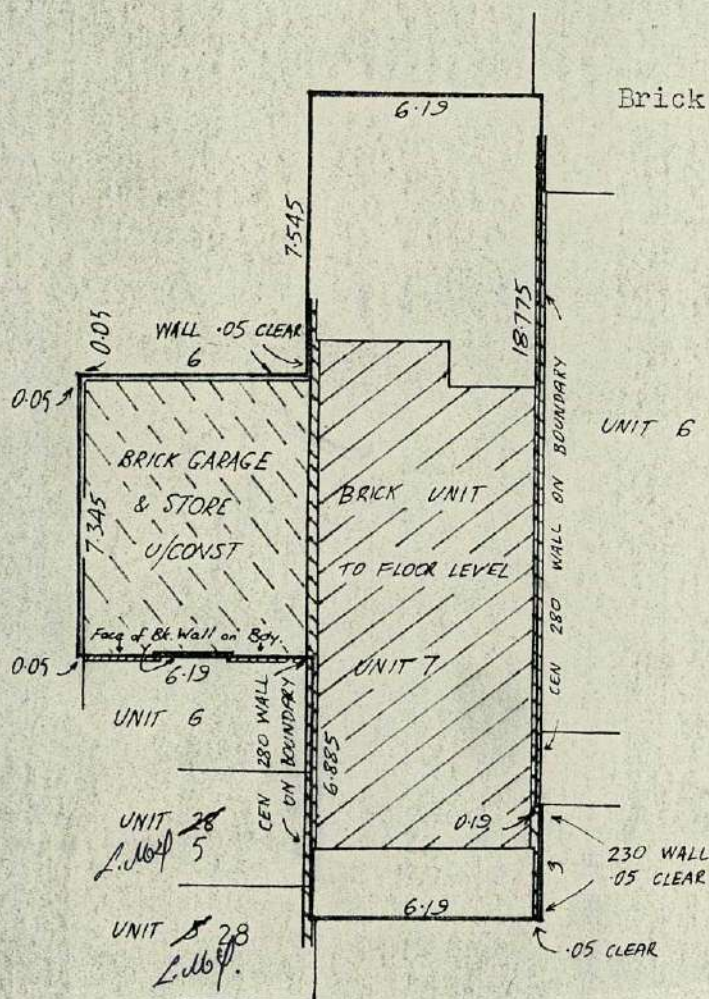
BLOCK 2  
SEC 8

Brick Garage and Store added 10/10/80.

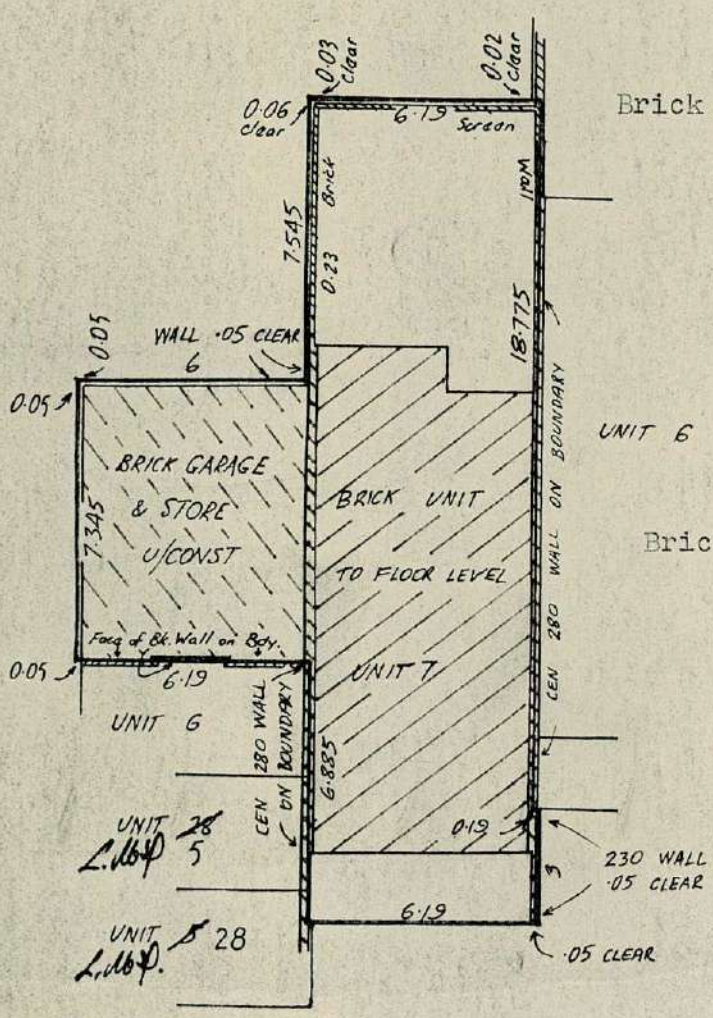
BLOCK 2  
SEC 8

Brick Screen Wall

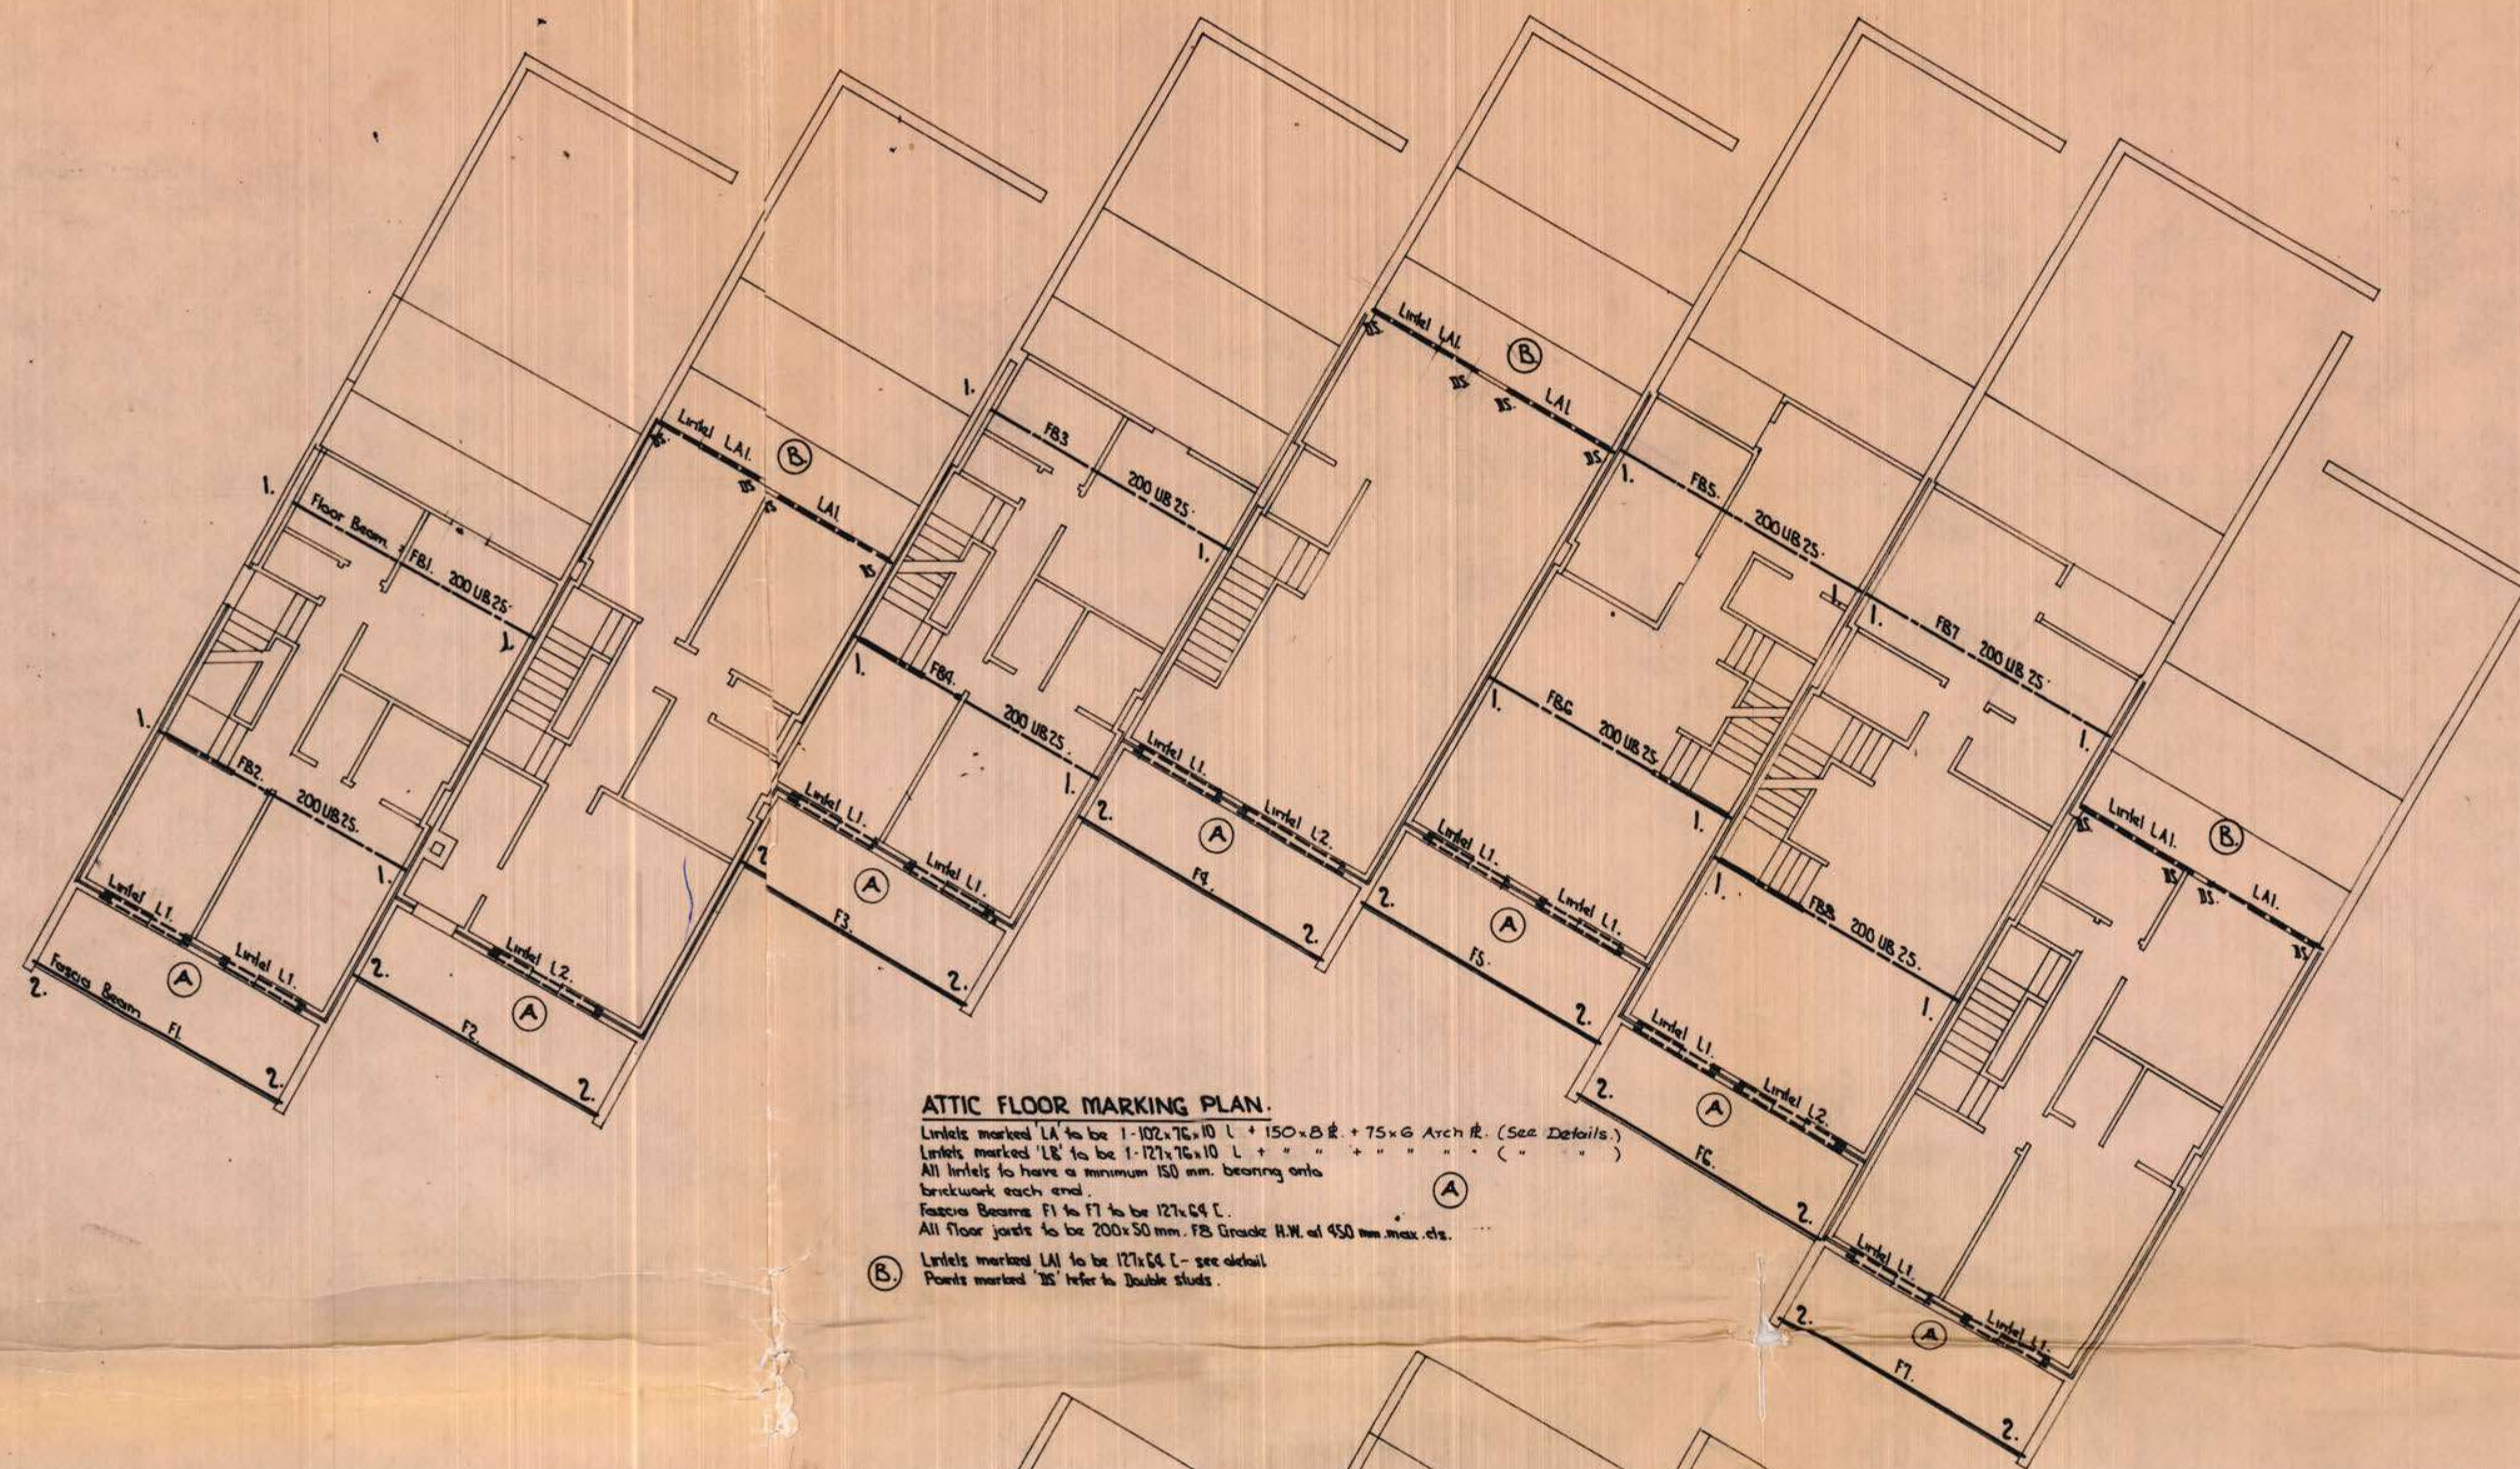
ATTIC FLOOR MARKING PLAN.

Lintels marked 'LA' to be 1-102x76x10 L + 150x8 R + 75x6 Arch R. (See Details.)  
Lintels marked 'LB' to be 1-121x76x10 L + " " " " " "  
All lintels to have a minimum 150 mm bearing onto  
brickwork each end.

Fascia Beams F1 to F7 to be 127x64 C.  
All floor joists to be 200x50 mm. F8 Grade 4 H.W. all 950 mm max etc.

Labels marked LAI to be 127x64 [- see detail  
Points marked 'DS' refer to Double studs.

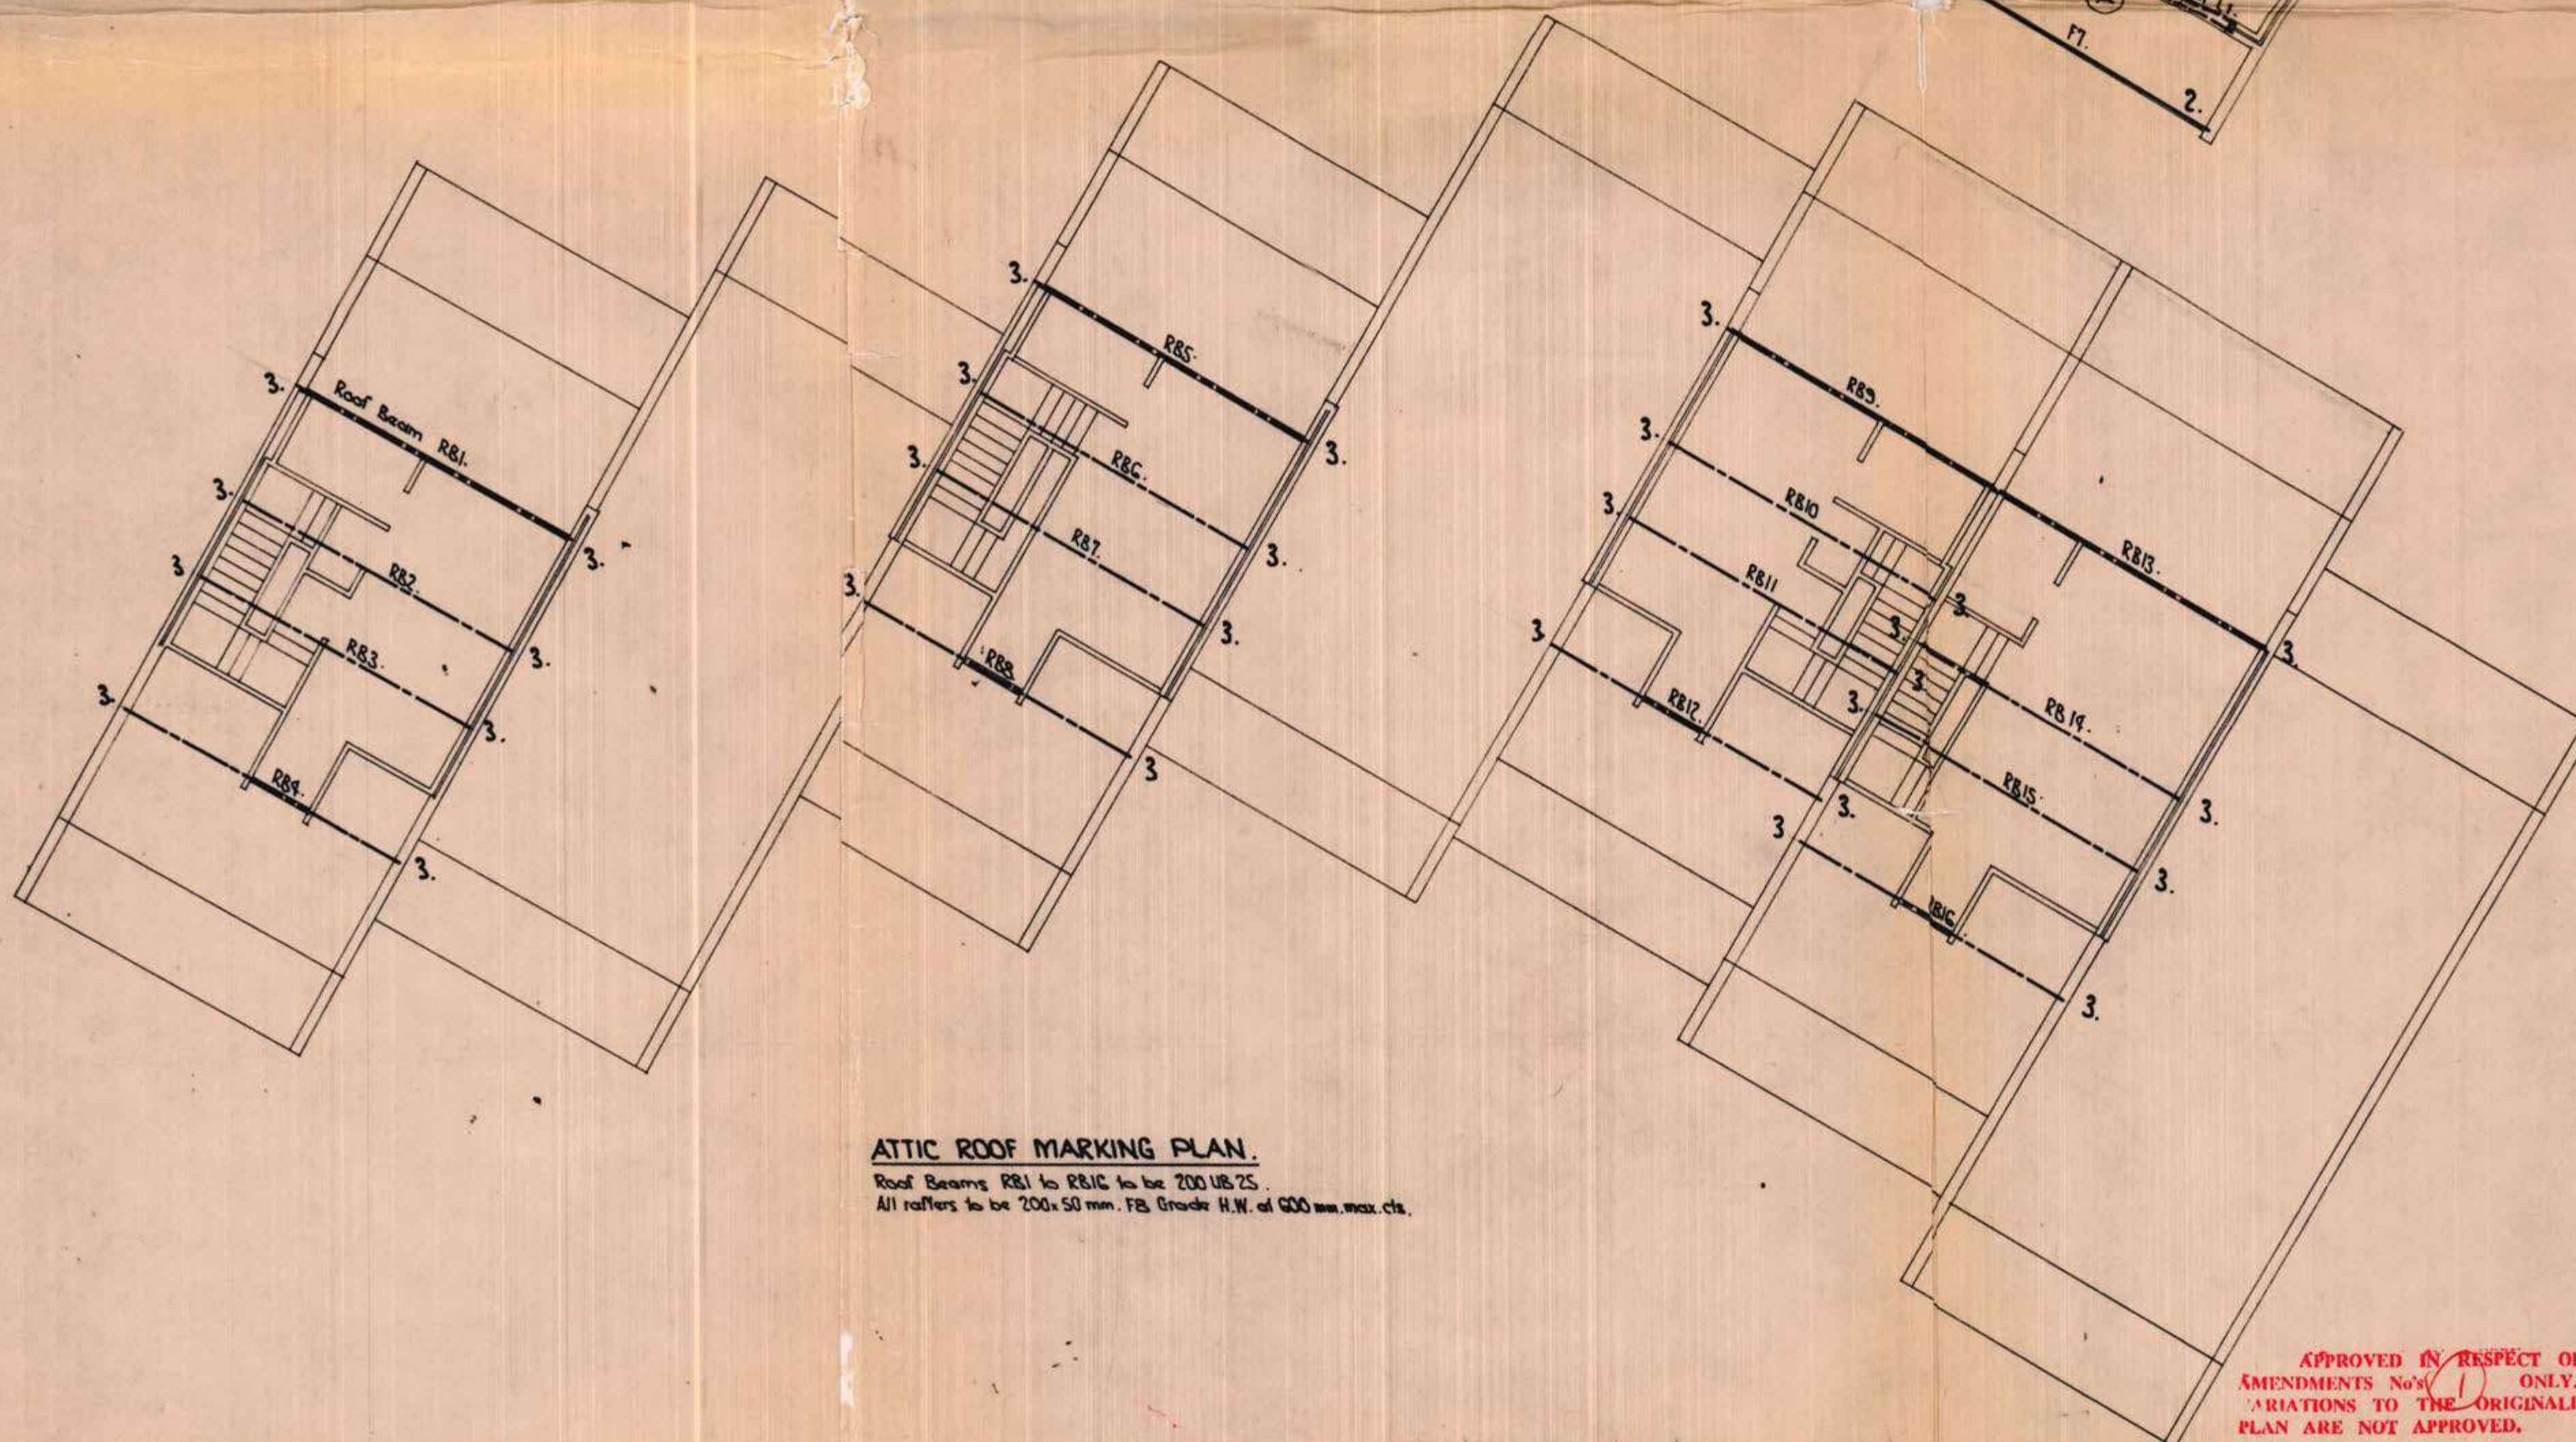
ATTIC ROOF MARKING PLAN.

Roof Beams RB1 to RB16 to be 200 UB25.  
All rafters to be 200x50 mm. F8 Grade H.W. at 600 mm max. cts.

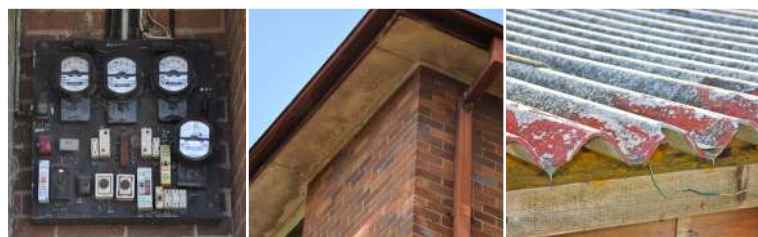
- 1. Exterior**  
roof sheeting, gutters, downpipes,  
ridge capping, eaves, cladding,  
electrical switchboards

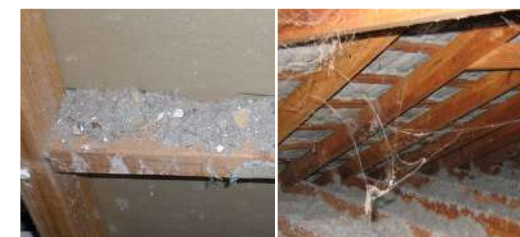
- 5. Building cavities**  
A small number of homes may still contain  
loose fill asbestos insulation in the roof  
cavity, wall cavities or sub-floor space

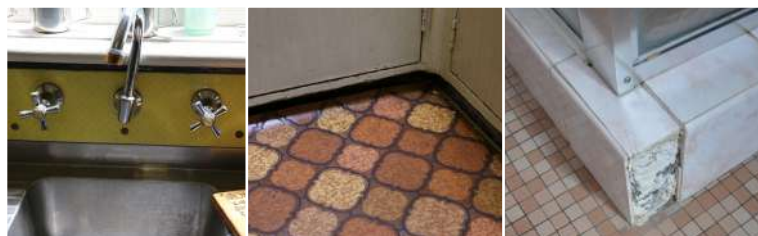
- 2. Wet areas - bathroom, laundry and kitchen**  
wall and ceiling panels, vinyl floor tiles, backing for wall tiles  
and splashbacks, hot water pipe insulation

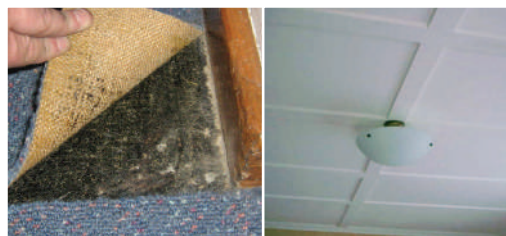
- 3. Internal areas**  
wall and ceiling panels, carpet underlay,  
textured paints, insulation in domestic  
heaters

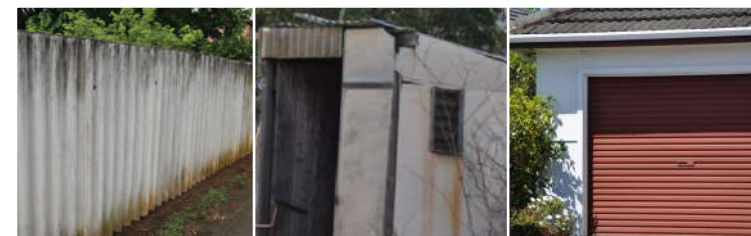
- 4. Backyard**  
fences, sheds, garages, carports, dog kennels, buried or  
dumped waste, letterboxes, swimming pools
